Repair of Earthquake-Damaged Square R/C Columns with Glass Fiber-Reinforced Polymer

Sassan Eshghi¹, Vahid Zanjani-zadeh²

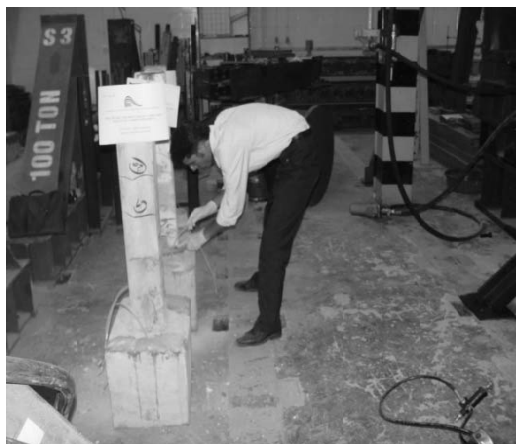
Fig.8 Cleanig surface of the damaged columns

All three specimens in as-built condition were tested and then were repaired by first replacing the loosened concrete with quickset cement then were cleaned with a high pressure gun and completely dried before the vinyl ester was applied to their surfaces (Fig.8). Special measures were taken to ensure that there were no voids between the

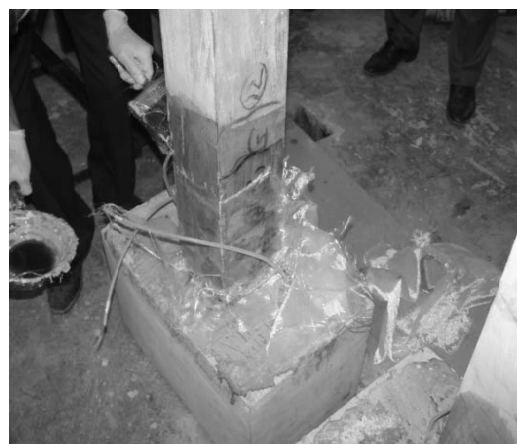
Fig.9 Installation of prefabricated composit sheets

sheets and the concrete surfaces. After the application of the first layer of the GFRP sheet, a second layer of vinyl ester sheet was applied on the surface of the first layer to allow impregnation of the second layer of the GFRP sheet.

The wrapping of the columns continued to the upper region of the column (Fig.9). All the repaired specimens were cured at least for 7 days to ensure that full strength had obtained before testing.
