Repair of Earthquake-Damaged Square R/C Columns with Glass Fiber-Reinforced Polymer

Sassan Eshghi¹, Vahid Zanjanizadeh²

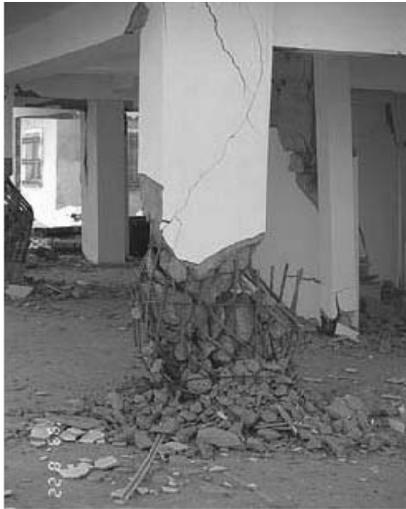
Fig.1 Failure of lap splice due to widely spaced ties with 90° hooks (Izmit-1999)

The most common types of non-ductile details are short splice length and wide ties with 90° hooks. These details had led to considerable damages in recent earthquakes. Fig.1 and Fig.2 show two-column damage in Izmit and Northridge earthquakes due to such detailing.

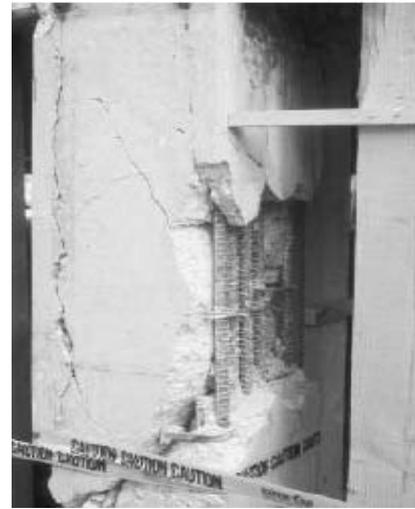
Fig.2 Failure of lap splice due to insufficient splice length and widely spaced ties with 90° hooks (Northridge-1994)

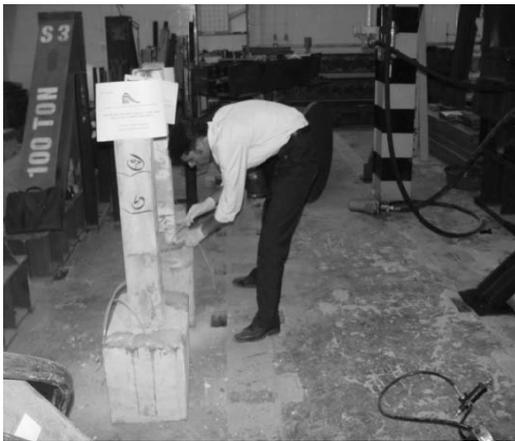
Fig.8 Cleanig surface of the damaged columns

All three specimens in as-built condition were tested and then were repaired by first replacing the loosened concrete with quickset cement then were cleaned with a high pressure gun and completely dried before the vinyl ester was applied to their surfaces (Fig.8). Special measures were taken to ensure that there were no voids between the

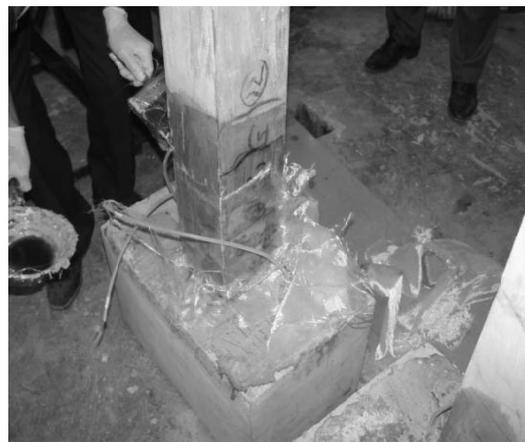
Fig.9 Installation of prefabricated composit sheets

sheets and the concrete surfaces. After the application of the first layer of the GFRP sheet, a second layer of vinyl ester sheet was applied on the surface of the first layer to allow impregnation of the second layer of the GFRP sheet.

The wrapping of the columns continued to the upper region of the column (Fig.9). All the repaired specimens were cured at least for 7 days to ensure that full strength had obtained before testing.

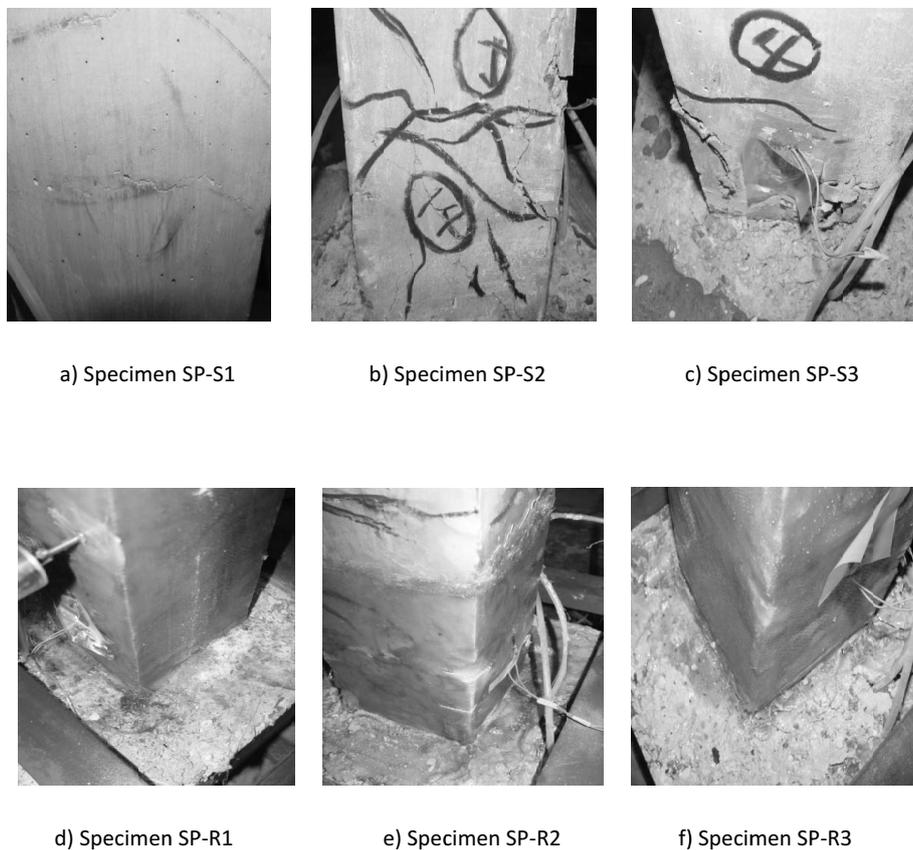
Fig.12 Specimens at end of testing

During testing of specimen SP-S1 at 1% drift ratio, initial flexural cracks were observed at the column footing interface and at 1.5% drift ratio the same cracks at the column footing

splice length. Some flexural cracks appeared along the splice length during the test but the length and width of these cracks did not increase significantly (Fig.12a).

In specimen SP-S2 flexural cracks on the column face started as early as at 1% lateral drift ratio. At this time longitudinal cracks were formed at right and left sides of the specimen. During the second cycle at 3.5% drift as fairly large sections of the concrete cover spalled at the column footing interface. The lateral load strength diminished, indicating that bond along the spliced bars was deteriorating. Shear cracking was observed at 2.5% drift but these cracks were not significant throughout the test. Damage in this specimen was severer than that in the

previous one (Fig.12b).

Specimen Sp-S3 was subjected to a $(0.15 A_g f'_c)$ constant axial load and initial flexural longitudinal cracks suddenly appeared at 1.5% drift ratio. In this test, cracking formed later but cracking propagation developed suddenly as the load applied. In this specimen the cover spalled completely at the corner at 4.5% drift ratio and the longitudinal bars were clearly visible. Along the splice length, there was severe damage. Shear cracks were observed at 3.5% drift ratio on the right and left faces of the columns and concrete crushing and spalling were observed just before the end of the test. In this specimen damage was generally severer than SP-S1 and SP-S2 (Fig.12c).

Stiffness of the repaired specimens had been deteriorated under large reversed cyclic loading. Large amount of the damages were concentrated in FRP sheets and some small sheet rupture was observed in high drift ratio. Damage in the concrete of repaired columns was slight. Vertical and horizontal flexural cracking, that occurred above the FRP jacket in past testing, opened and closed during retesting. Nevertheless, in the SP-R1, damage was very low and very little stress concentration was occurred in FRP sheets. Some new cracks were observed in all repaired specimens but they were not significant. At the end of the test, cracks in all specimens propagated along the columns but in SP-R3 the sustained damage was more serious than two others. Cracks in SP-R1 were little and narrow. During the test, cracks at the column footing interface of SP-R3 were very serious and some spalling and crushing were appeared. So it indicated that high axial load led to more serious damage in the specimens. SP-R1 behaved better and no delaminating or rupture across the fibers of the jackets was observed in this specimen

(Fig.12d, 12e, 12f).
