# Repair of Earthquake-Damaged Square R/C Columns with Glass Fiber-Reinforced Polymer

Sassan Eshghi<sup>1</sup>, Vahid Zanjani-zadeh<sup>2</sup>

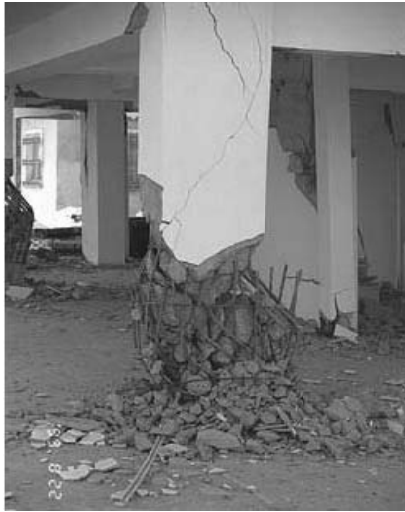
**Fig.1** Failure of lap splice due to widely spaced ties with 90° hooks (Izmit-1999)

The most common types of non-ductile details are short splice length and wide ties with 90° hooks. These details had led to considerable damages in recent earthquakes. Fig.1 and Fig.2 show two-column damage in Izmit and Northridge earthquakes due to such detailing.

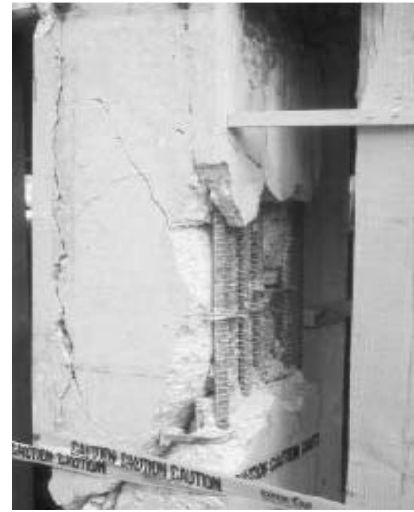
**Fig.2** Failure of lap splice due to insufficient splice length and widely spaced ties with 90° hooks (Northridge-1994)

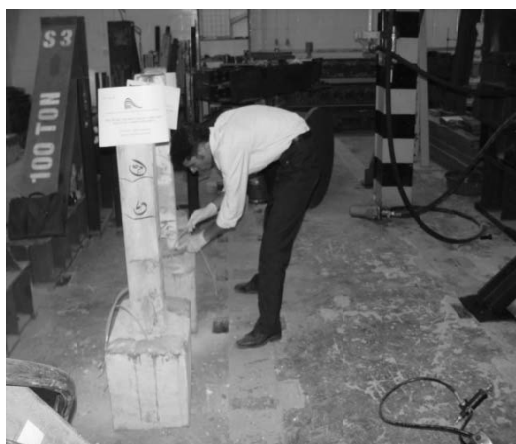
**Fig.8** Cleanig surface of the damaged columns

All three specimens in as-built condition were tested and then were repaired by first replacing the loosened concrete with quickset cement then were cleaned with a high pressure gun and completely dried before the vinyl ester was applied to their surfaces (Fig.8). Special measures were taken to ensure that there were no voids between the

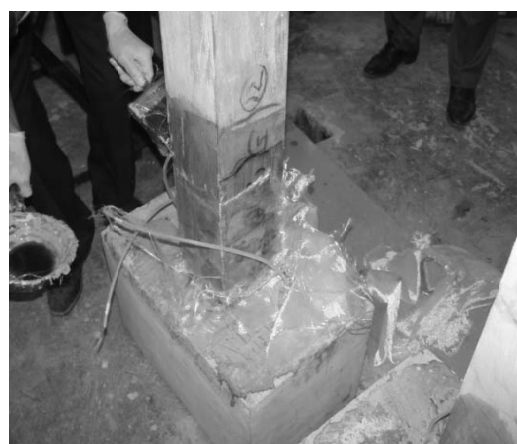
**Fig.9** Installation of prefabricated composit sheets

sheets and the concrete surfaces. After the application of the first layer of the GFRP sheet, a second layer of vinyl ester sheet was applied on the surface of the first layer to allow impregnation of the second layer of the GFRP sheet.

The wrapping of the columns continued to the upper region of the column (Fig.9). All the repaired specimens were cured at least for 7 days to ensure that full strength had obtained before testing.

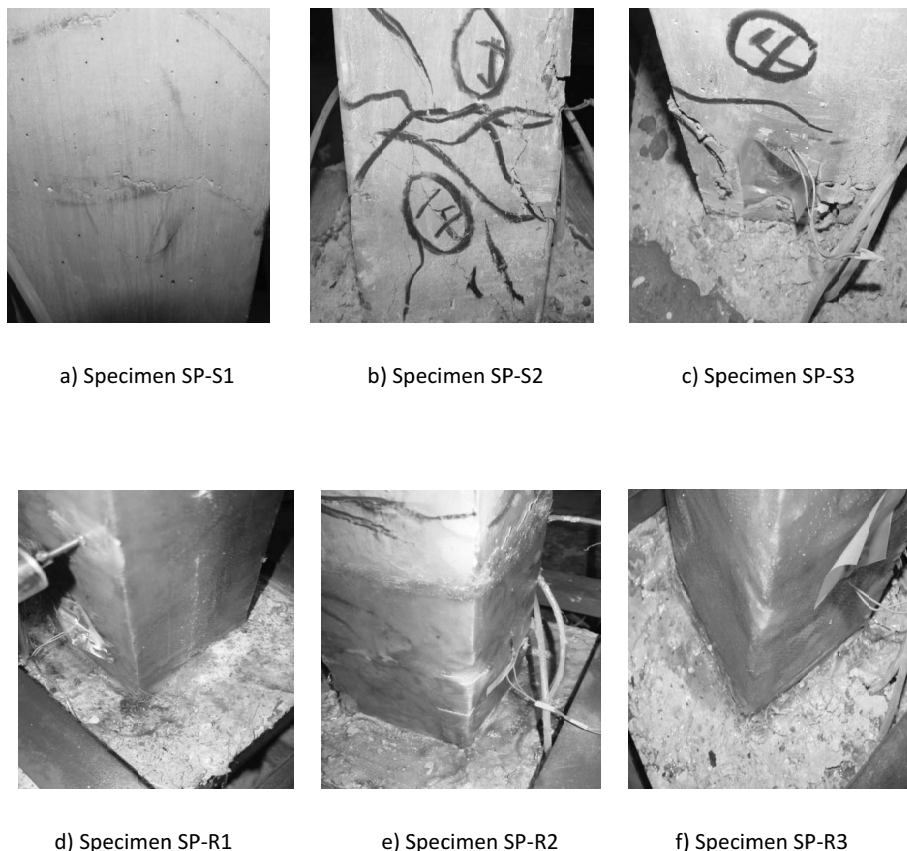
**Fig.12** Specimens at end of testing

During testing of specimen SP-S1 at 1% drift ratio, initial flexural cracks were observed at the column footing interface and at 1.5% drift ratio the same cracks at the column footing

splice length. Some flexural cracks appeared along the splice length during the test but the length and width of these cracks did not increase significantly (Fig.12a).

In specimen SP-S2 flexural cracks on the column face started as early as at 1% lateral drift ratio. At this time longitudinal cracks were formed at right and left sides of the specimen. During the second cycle at 3.5% drift as fairly large sections of the concrete cover spalled at the column footing interface. The lateral load strength diminished, indicating that bond along the spliced bars was deteriorating. Shear cracking was observed at 2.5% drift but these cracks were not significant throughout the test. Damage in this specimen was severer than that in the

previous one (Fig.12b).

Specimen Sp-S3 was subjected to a  $(0.15 A_g f'_c)$  constant axial load and initial flexural longitudinal cracks suddenly appeared at 1.5% drift ratio. In this test, cracking formed later but cracking propagation developed suddenly as the load applied. In this specimen the cover spalled completely at the corner at 4.5% drift ratio and the longitudinal bars were clearly visible. Along the splice length, there was severe damage. Shear cracks were observed at 3.5% drift ratio on the right and left faces of the columns and concrete crushing and spalling were observed just before the end of the test. In this specimen damage was generally severer than SP-S1 and SP-S2 (Fig.12c).

Stiffness of the repaired specimens had been deteriorated under large reversed cyclic loading. Large amount of the damages were concentrated in FRP sheets and some small sheet rupture was observed in high drift ratio. Damage in the concrete of repaired columns was slight. Vertical and horizontal flexural cracking, that occurred above the FRP jacket in past testing, opened and closed during retesting. Nevertheless, in the SP-R1, damage was very low and very little stress concentration was occurred in FRP sheets. Some new cracks were observed in all repaired specimens but they were not significant. At the end of the test, cracks in all specimens propagated along the columns but in SP-R3 the sustained damage was more serious than two others. Cracks in SP-R1 were little and narrow. During the test, cracks at the column footing interface of SP-R3 were very serious and some spalling and crushing were appeared. So it indicated that high axial load led to more serious damage in the specimens. SP-R1 behaved better and no delaminating or rupture across the fibers of the jackets was observed in this specimen

(Fig.12d, 12e, 12f).
