## Technical Note

# Repair effectiveness of CFRP and steel plates in RC beams with web opening: effect of plate thickness

### Abstract

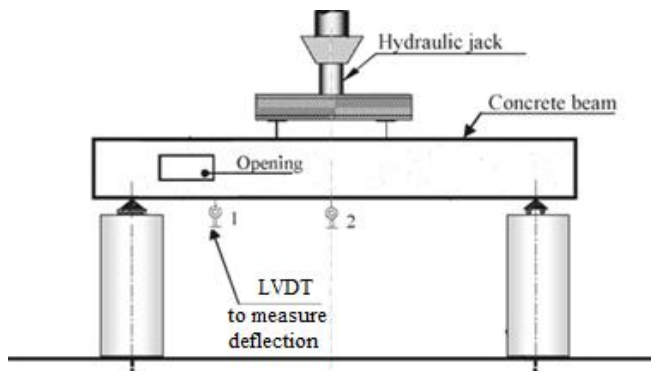
All beams were tested as simple supported beams subjected to a four-point load, as illustrated in Fig. 1. A universal testing machine with 300 kN capacity was used in order to apply the load on a steel distribution I- beam, which was used to generate the two concentrated loads on the beam. The load was applied gradually with a speed of 4 kN/min and was then released with the same average. Two linear variable differential transformers (LVDT) were used in each test to monitor vertical deflection at two locations, edge of the opening and mid-span of the beam as shown in Fig. 1. For each beam, one strain gauge was attached to the main flexure steel bars below the opening, as shown in Fig. 2 (a). For all the beams, two strain gauges were attached directly to the CFRP and steel plate on the sides of beams to monitor strain variation in CFRP and steel plates, as shown in Fig. 2 (b). All the used electrical devices (load cell, LVDT, and strain gauges) are attached to the data logger in order to monitor the variation in load, deflection and train values, corresponding to applied loads. The readings were carried out at each 5 kN load step and up to the ultimate applied load. All the beams were subjected to failure load at the pre-repair stages. The beams were then unloaded by bringing back the loading to zero.

**Fig. 1** Test set-up

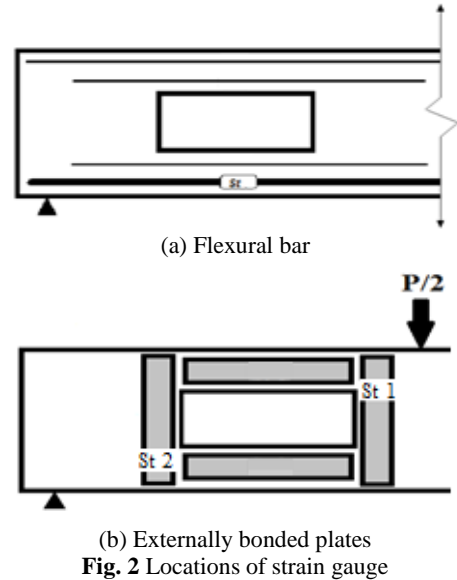
(a)

**Fig. 2** Locations of strain gauge

The behaviour of load-strain relationship for externally bonded CFRP and steel plates is presented in this section. Strain gauge are fixed at two locations, one locations is on the opening corner near the support (ST2) and another location is at the opening corner near the point of applied load (ST1), as shown in Fig. 2(b). The load against strain curves for beams B1, B2, B3 and B4 are shown in Figs. 7, 8, 9 and 10, respectively. The recorded strains indicate that the value of strain for all beams did not reach the ultimate

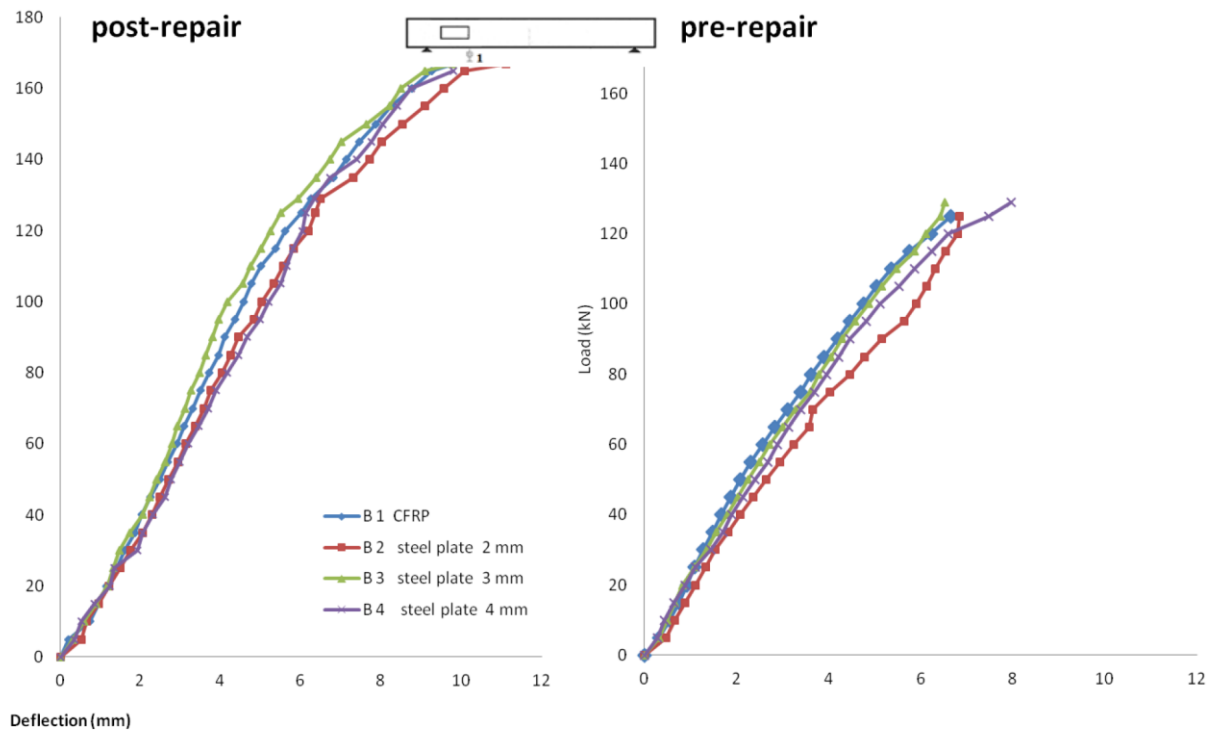
The load-deflection relationship at the mid span and below the edge of the opening is presented in this section. All the beams showed lower deflection at the mid span as compared to the deflection at the edge of the opening. For deflection at the edge of the opening, the reduction in deflection values found to be 10 % for CFRP, as shown in Table 4. For steel plates, the reductions in deflection were 7 %, 9 %, and 10 % for thicknesses of 2 mm, 3 mm and 4 mm, respectively. Thus, it is clear that the externally bonded plates applied around the web opening are capable of reducing 10 % of the deflection at pre-repair stage.

The beam B2, which was repaired by a steel plate with a thickness of 2mm, shows an effect on deflection at the edge of the opening, where at load of 128 kN the deflection is 6.98 mm and 6.49 mm at pre and post repair stages, respectively. For beam B3, good effect on the load capacity and a good effect on deflection were proved. The highest value of deflection was 6.52 mm obtained at the edge of the opening and it was at the pre-repaired stage at a failure load of 129 kN. However, at the post-repair stage, the deflection for the same load of 129 kN was 5.92 mm. As shown in Fig. 4, which shows the load against deflection at edge of opening curves at pre and post repair stages, the highest effect on deflection was for beams B1 and B4, while the lowest effect on deflection was for beam B2. The value of deflection for beam B1 at the pre-repair stage was 6.58 mm at a failure load of 125.2 kN, while the deflection was 5.95 mm at the post-repair stage at the same load of 125.2 kN.

**Fig. 4** Load–deflection curves at the edge of the opening at pre and post repair stages

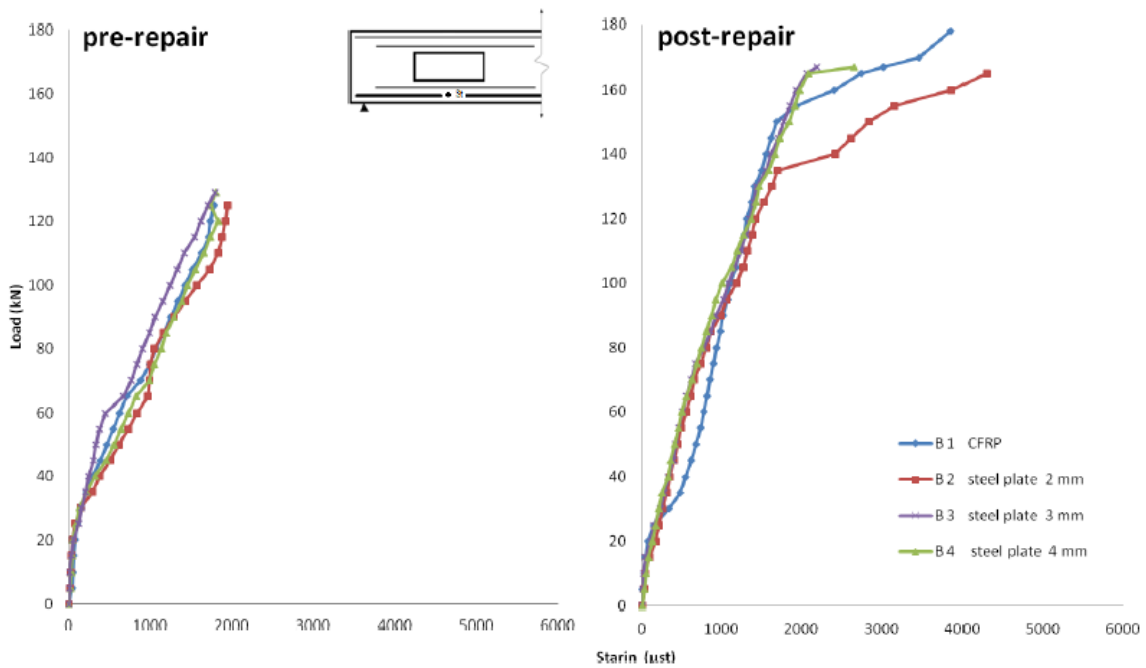
The load-strain relationship of steel reinforcement is presented in this section. The strain gauge (St) was attached onto the main steel reinforcement bar at the middle of the opening in the bottom chord. Fig. 6 shows the load against steel bar strain of the strain gauge (St) at the pre and post repair stages. For all the beams at the pre-repair stage, the strain gauge (St) shows an increase in strain value with the

increase in applied load and reaches its yielded strain at the ultimate load. At the post-repair stage, the externally bonded CFRP and steel plate shared the strain with steel bars where the strain gauge (St) reached strain values less than the strain at the pre-repair stage at same load. This was subjected to a different in the decrease of strain values percentage a depending on the material and thickness that were used, as shown in Table 5.

**Fig. 6** Load against steel bar strain of (St) at pre and post repair stages

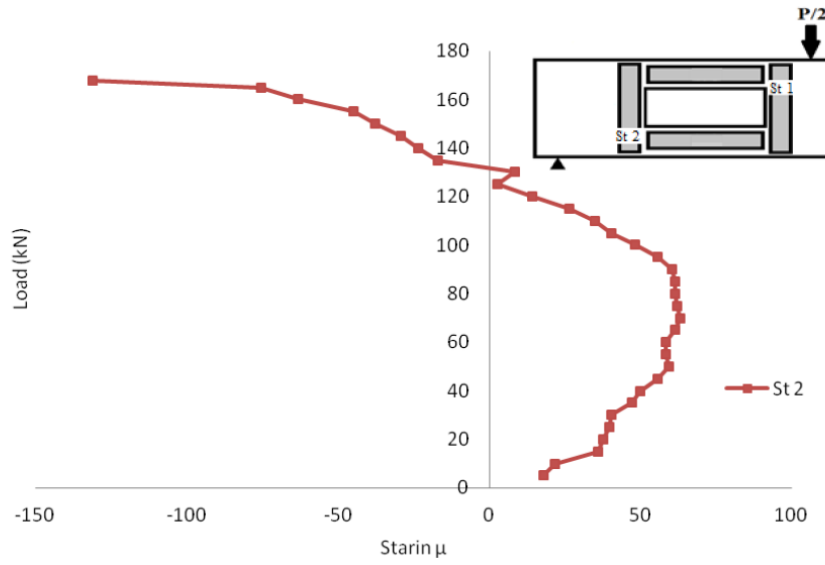
**Fig. 8** Load against strain of externally bonded steel plate of beam B2

strain of CFRP and steel plates. This is due to the fact that the concrete failed before allowing the repair materials to reach the ultimate strain values. It can be observed from Figs. 7 to 10 that the externally bonded plates start to share the strain in the beam from the start of the applied load. The results are in agreement with Khalifa and Intomio [20], who found that the maximum CFRP vertical strain measured at failure corresponded to 14 % of the reported CFRP ultimate strain. This value is not absolute, because it greatly depends on the location of the strain gauge with respect to a crack.

As can be seen from Fig. 7, for beam B1 the maximum CFRP strain measured at failure was in strain ST1. For beam B3, the steel plate strain measured at failure was deferent at each location, because the value of the strain greatly depends on the location of the strain gauge with respect to a crack, as shown in Fig. 9. It can be observed from Fig. 10 that for beam B4, the maximum CFRP strain measured at failure was in strain ST1, on the bottom chord of the opening. CFRP and steel plates were not fractured or debonded from the concrete surface, and this ultimately indicates that CFRP and steel plates could provide additional strength if the beams did not fail by concrete diagonal shear cracks.

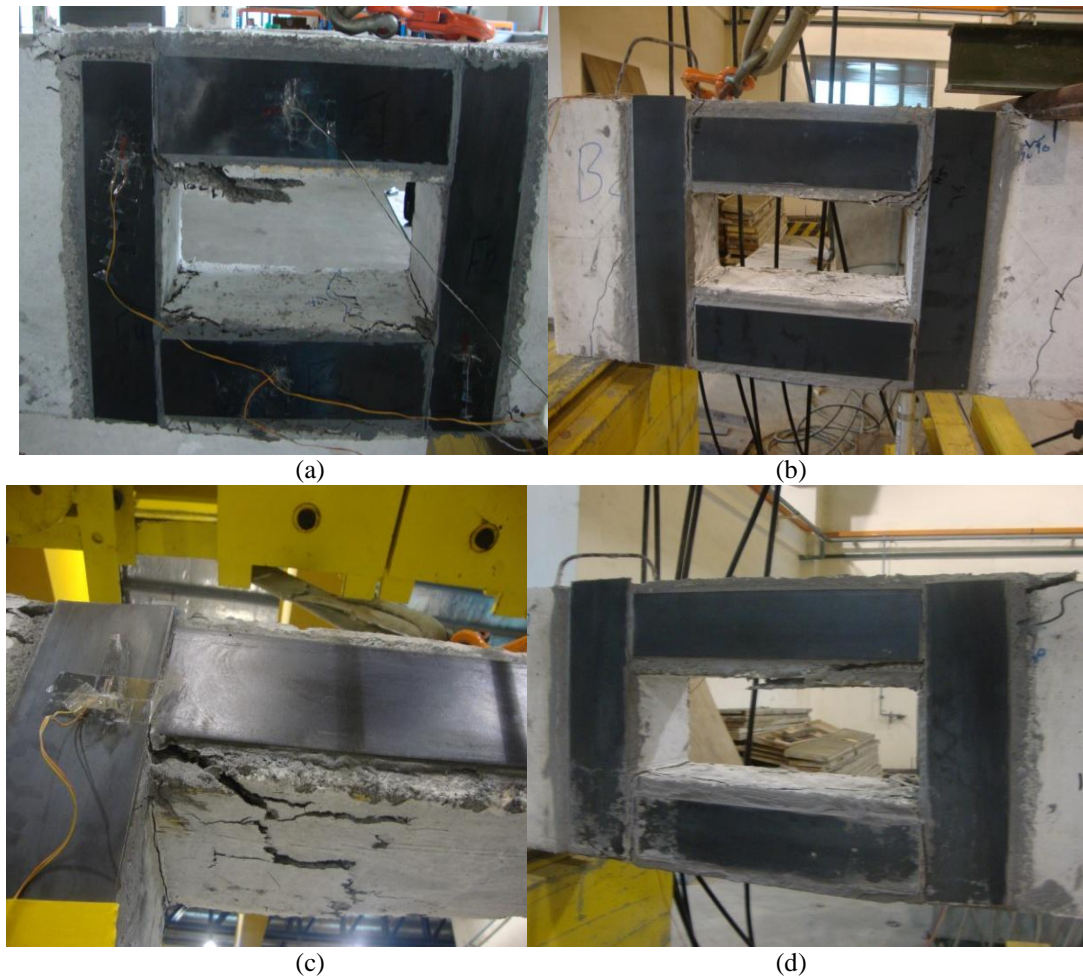
The crack pattern and the failure modes for all beams at pre and post repair stages are presented in this section. Figs. 11 and 12 show the crack pattern and the failure mode for all the beams at the pre and post repair stages, respectively. The failure modes of all the beams are similar because the failure occurs due to failure in concrete as diagonal shear failure before the externally bonded plates reach the ultimate strain. It can be seen from Fig. 11 (b) that the first diagonal crack for beam B2 was observed at the corner of the opening at a load of 35 kN; additional cracks were formed with the increase of the applied load. Failure of the beam occurred when the total applied load reached 128 kN. At the post-repair stage, many cracks were formed at the solid span of the beam, and the failure of the beam occurred at a load of 163.4 kN. At failure, concrete diagonal shear failure was observed around the

opening, as shown in Fig. 12 (b).

This mode of failure is called splitting failure, which is due to relatively high longitudinal compressive stress developed at the top of the chords, which created transverse tension, and led to splitting failure, as according to Khalifa and Nanni [22]. The CFRP sheet did not fracture or debond from the concrete surface at the ultimate load. As can be seen from Fig. 11 (d), the first diagonal crack for beam B4 was observed at the corner of the opening at a load of 35 kN, additional cracks were formed with the increase of the applied load. Failure of the beam occurred when the total applied load reached 129.3 kN. As shown in Fig. 12 (d) for beam B4 at the post-repair stage, many cracks were formed at the solid span of the beam and the failure of the beam occurred at a load of 170 kN. At failure, crushing of the concrete was observed on the top and bottom face of the chord members, due to high compressive stress in concrete before the externally bonded plates reach the maximum strain.

Fig. 12 Failure modes of beams at the post-repair stage (a) Beam B1, (b) Beam B2, (c) Beam B3, (d) Beam B4
