## Investigation of long term coupled effect of high temperature and constant high humidity on corrosion rehabilitated patches of reinforced concrete structures

### Abstract

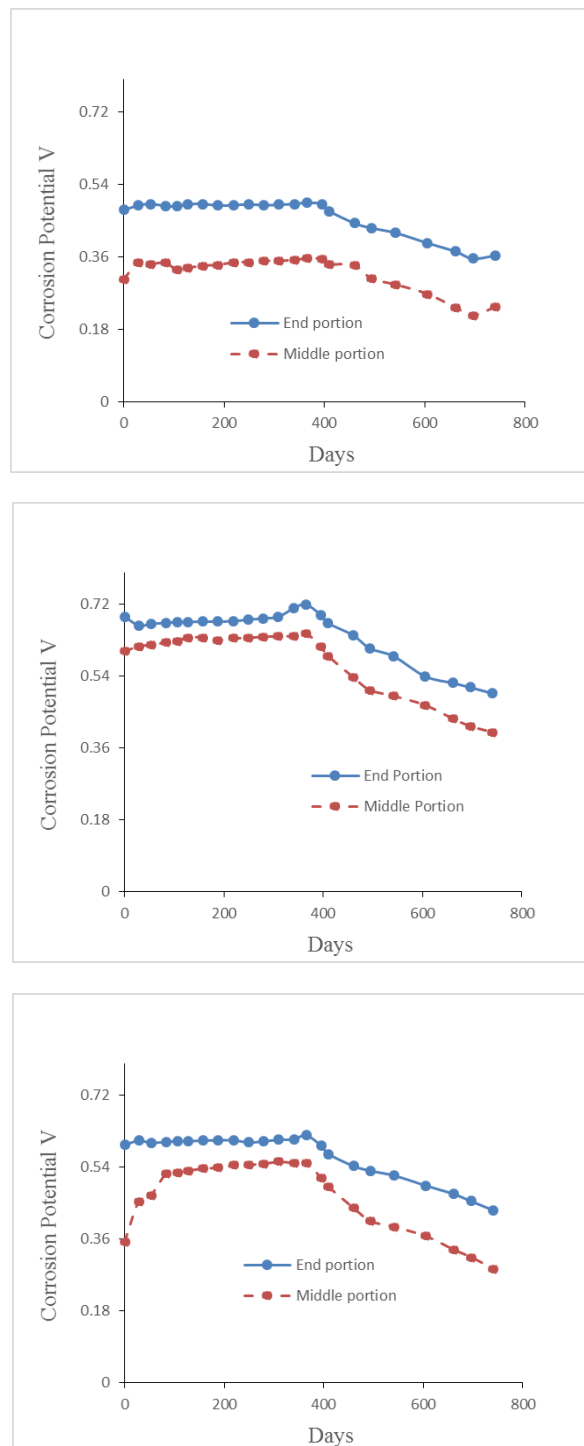
**Fig. 5** (a-c) Corrosion potential measurement for 5% contaminated chloride specimen at the end kept at 30°C, 40°C and 50°C

1) At the middle non contaminated portion of the specimen having 5% chloride at the end portions and kept at  $50^\circ C$  (#1 and #2), the maximum corrosion of **-0.235** Volts was found after 2 years as compared to **-0.285** Volts at  $30^\circ C$  in the middle zero chloride portion of the same specimens (#5 and #6). However previously, much higher readings of these specimens were obtained on completion of one year observations [10]. The reason of this phenomenon could be the long term coupled effect of temperature and constant high humidity due to which the decline in corrosion potential after two years was significant. The results are shown in Figs. 5 and 6.

2) The maximum corrosion potential reading of the specimens #1 and #2 was found **-0.363** Volts as compared to high chloride induced potentials of **-0.432** Volts (figure 5) of the same specimens #5 and #6 at  $30^\circ C$  (figure 4)

3) At the middle non contaminated portion of the specimen #3 and #4 which were put at 40 °C maximum corrosion potential of **-0.399** Volts was found, being higher than the other specimens at 30 and 50 °C.

4) The highest corrosion potential of **-0.497** Volts was found in specimens #3 and #4 as compared to **-0.363** Volts at the two extreme ends of the specimen #1 and #2. After

365 days of observations, significant decline was observed that potential dropped from **-0.702** to **-0.497** after one more year of observations.
