Technical Note

Repair effectiveness of CFRP and steel plates in RC beams with web opening: effect of plate thickness

Abstract

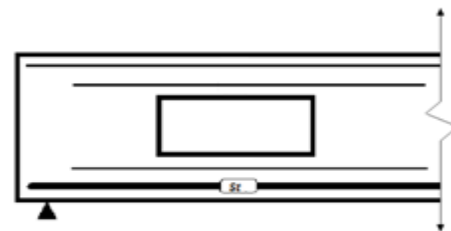
(b) Externally bonded plates
Fig. 2 Locations of strain gauge

(a) Flexural bar

The behaviour of load-strain relationship for externally bonded CFRP and steel plates is presented in this section. Strain gauge are fixed at two locations, one locations is on the opening corner near the support (ST2) and another location is at the opening corner near the point of applied load (ST1), as shown in Fig. 2(b). The load against strain curves for beams B1, B2, B3 and B4 are shown in Figs. 7, 8, 9 and 10, respectively. The recorded strains indicate that the value of strain for all beams did not reach the ultimate
