Investigation of long term coupled effect of high temperature and constant high humidity on corrosion rehabilitated patches of reinforced concrete structures

Abstract

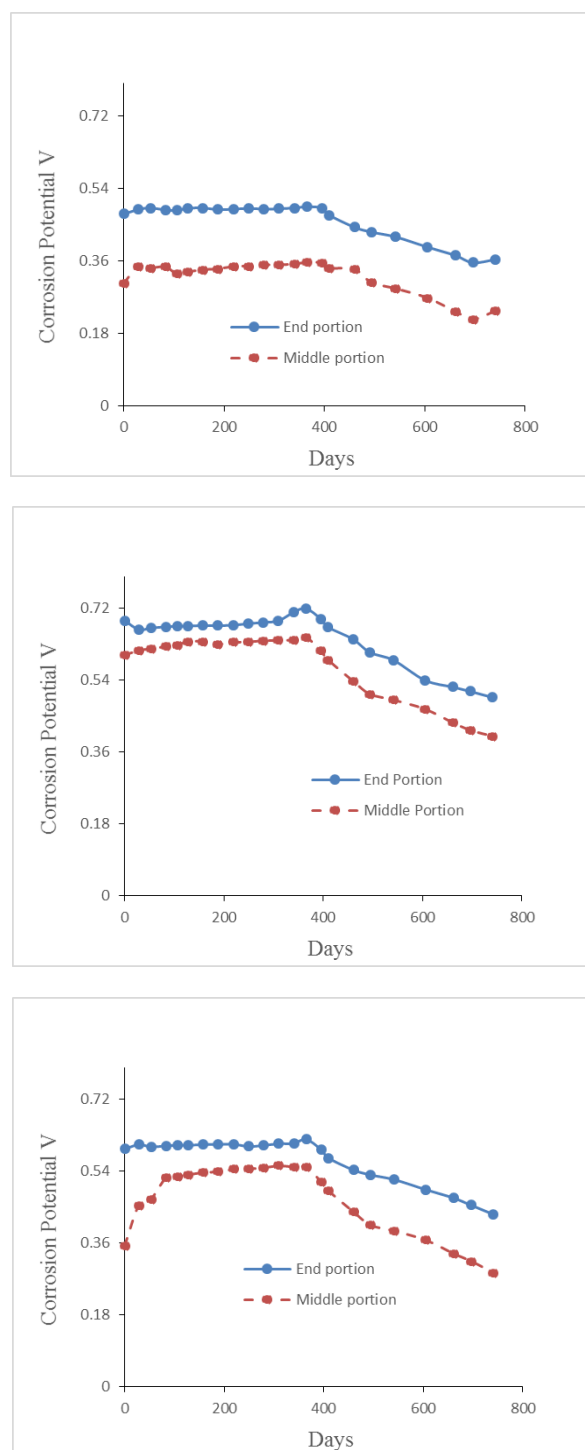
Fig. 5 (a-c) Corrosion potential measurement for 5% contaminated chloride specimen at the end kept at 30°C, 40°C and 50°C

1) At the middle non contaminated portion of the specimen having 5% chloride at the end portions and kept at 50°C (#1 and #2), the maximum corrosion of **-0.235** Volts was found after 2 years as compared to **-0.285** Volts at 30°C in the middle zero chloride portion of the same specimens (#5 and #6). However previously, much higher readings of these specimens were obtained on completion of one year observations [10]. The reason of this phenomenon could be the long term coupled effect of temperature and constant high humidity due to which the decline in corrosion potential after two years was significant. The results are shown in Figs. 5 and 6.

2) The maximum corrosion potential reading of the specimens #1 and #2 was found **-0.363** Volts as compared to high chloride induced potentials of **-0.432** Volts (figure 5) of the same specimens #5 and #6 at 30°C (figure 4)

3) At the middle non contaminated portion of the specimen #3 and #4 which were put at 40 °C maximum corrosion potential of **-0.399** Volts was found, being higher than the other specimens at 30 and 50 °C.

4) The highest corrosion potential of **-0.497** Volts was found in specimens #3 and #4 as compared to **-0.363** Volts at the two extreme ends of the specimen #1 and #2. After

365 days of observations, significant decline was observed that potential dropped from **-0.702** to **-0.497** after one more year of observations.
