## Investigation of long term coupled effect of high temperature and constant high humidity on corrosion rehabilitated patches of reinforced concrete structures

### Abstract

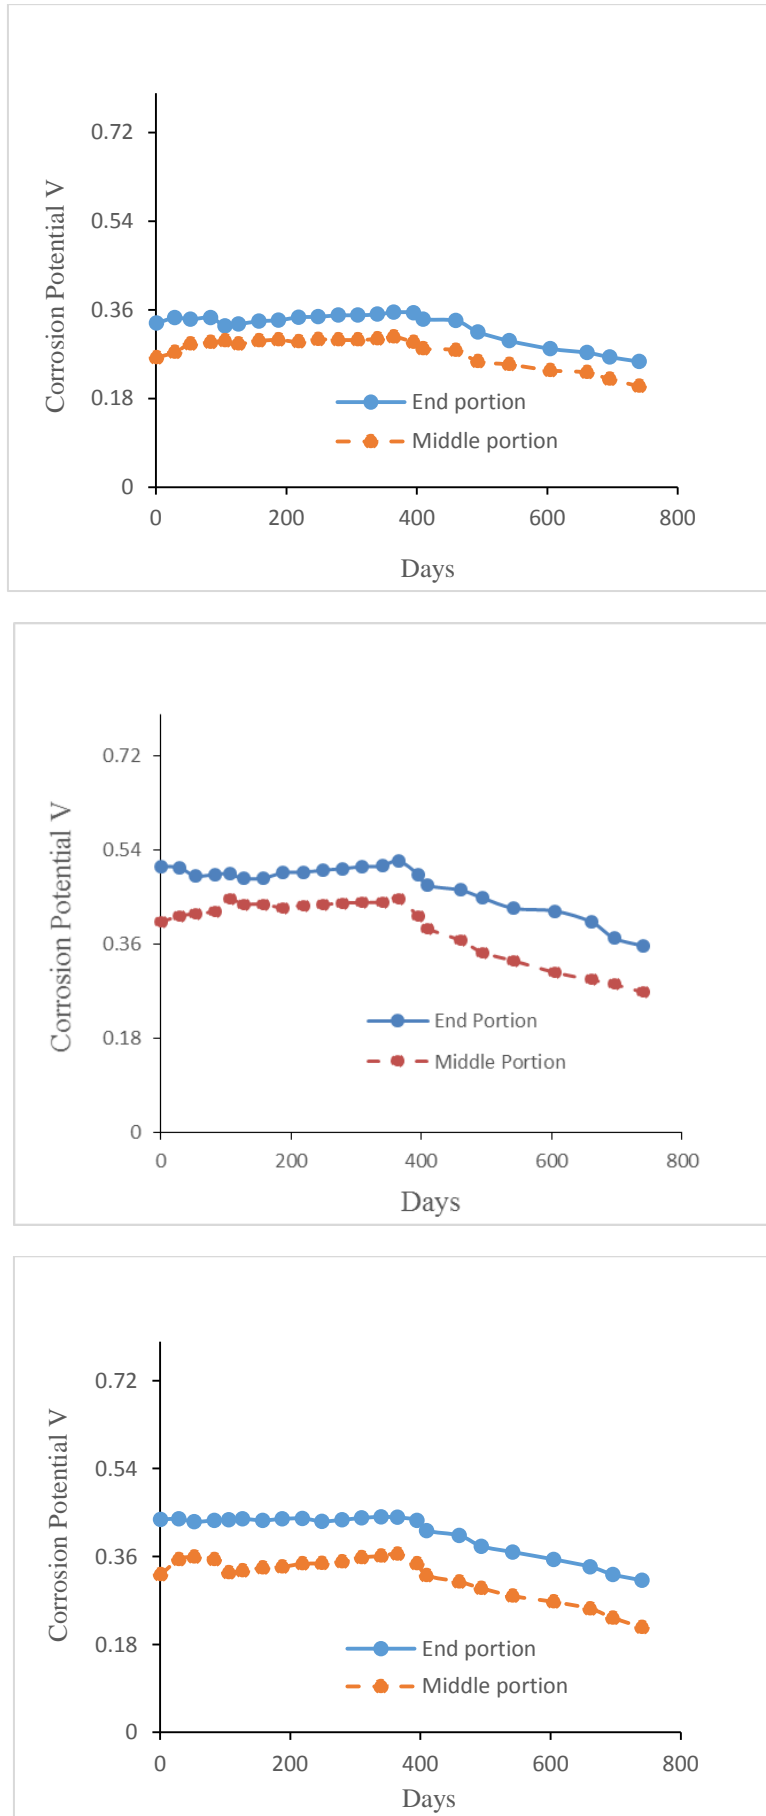
Fig. 6 (a-c) Corrosion potential measurement for 3% chloride contaminated specimen at the end kept at 30°C, 40°C and 50°C

1) At the middle non contaminated portion of the specimen having 5% chloride at the end portions and kept at  $50^\circ C$  (#1 and #2), the maximum corrosion of **-0.235** Volts was found after 2 years as compared to **-0.285** Volts at  $30^\circ C$  in the middle zero chloride portion of the same specimens (#5 and #6). However previously, much higher readings of these specimens were obtained on completion of one year observations [10]. The reason of this phenomenon could be the long term coupled effect of temperature and constant high humidity due to which the decline in corrosion potential after two years was significant. The results are shown in Figs. 5 and 6.

5) In the 3 % chloride contaminated specimens (#7 and #8) at the end, the corrosion potential of **-0.255** Volts was obtained as compared to high **-0.311** Volts of same specimens (#11 and #12) which were kept at 30 C°.

6) In specimen #7 and #8, the corrosion potential of **-0.205** volts at the middle non contaminated portion was obtained as compared to **-0.215** Volt at 30°C.

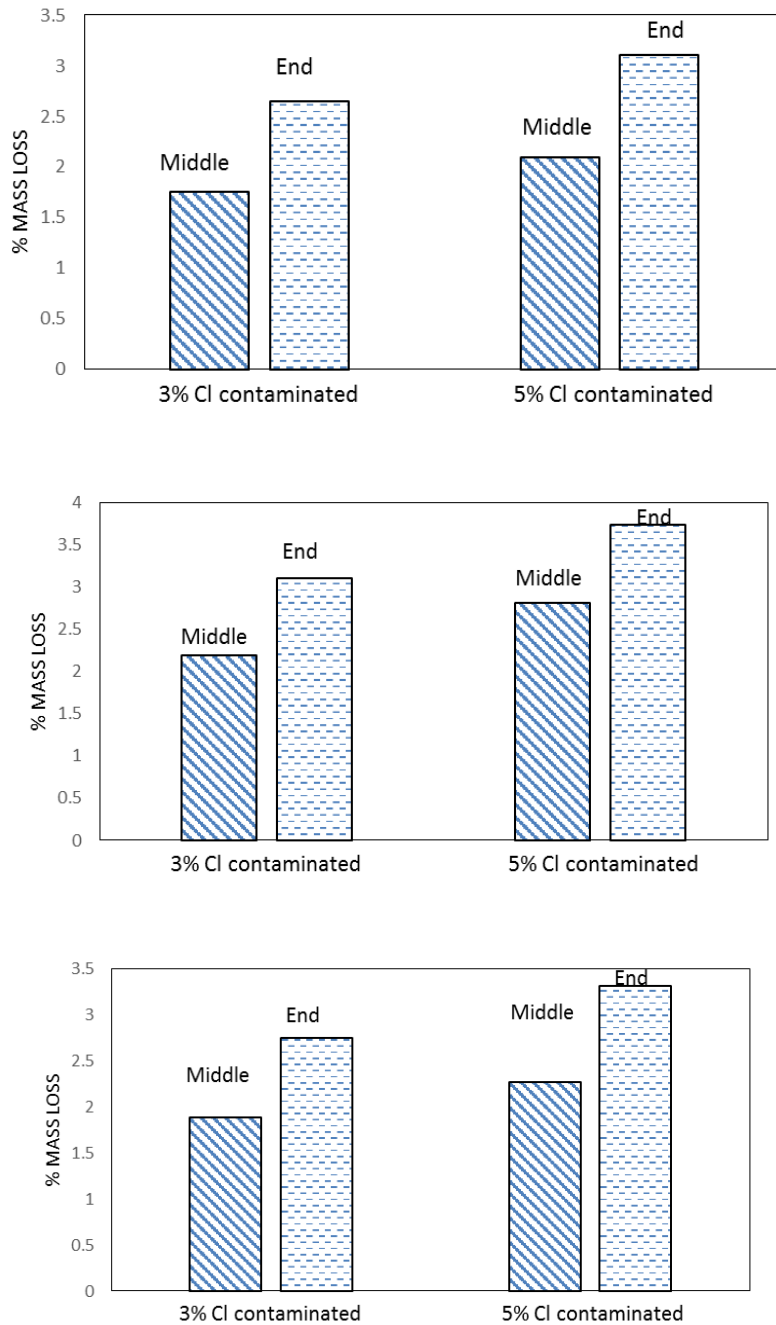
**Fig. 7** % Mass loss for 3% and 5% chloride contaminated specimen at the end kept at 30°C, 40°C and 50°C

1) The steel bar from the end portion of 5% chloride contaminated concrete gave the highest % mass loss of 3.73 at 40°C while the steel bar from its middle portion gave 2.81 % mass loss. When the steel taken from the end portion of the same specimen kept at 30°C gave the highest % mass loss of 3.11 and 2.09 % obtained from its middle steel. However interestingly even after exposure of two years observation, the

steel of the end portion of the same specimen kept at 50°C gave the highest % mass loss of 3.31 and middle steel gave 2.27 % mass losses which was lower than the mass losses at 40°C. The results are shown in Fig. 7.

2) The steel from the end portions of 3 % chloride contaminated concrete specimens kept at 30°C, 40°C and 50°C gave 2.65, 3.11 and 2.75 % mass loss respectively. While the middle steels from the uncontaminated portion of these specimens gave 1.75, 2.19 and 1.88 % mass losses respectively as shown in figure 7. Similarly in the 3% chloride contaminated specimens reduced % mass losses at 50°C obtained as compared to the mass loss at 40°C, confirming the authenticity of the results of this research.

As it can be seen from gravimetric mass loss results of various specimens put in varying temperatures, shown in figure 7(a-c), the steels from the middle portion of all the specimens simulating the actual patch repair in field, were corroded and gave approximately 70% of the mass loss obtained in their respective contaminated end portions, indicating the chloride transfer and vulnerability of repaired portion against corrosion.

The corrosion mass loss usually increases with the increase in chloride concentration justified with the sample having 3% and 5% chloride. However, interestingly even after the long term exposure of two years, the similar decline of corrosion potential and mass loss was observed at 50 °C as it was obtained in previous one year results [10]. The steel bars were corroded less at 50°C than at 40°C as indicated from the corrosion potential and mass loss results as shown in figures and . One of the reasons could be the unavailability of oxygen at such a high temperature and R.H which are must for corrosion process to occur. The increased temperature resulted in decreased solubility of oxygen in the pore solution of concrete at the ITZ and high R.H created disconnection in the concrete pores providing obstacles in the oxygen path from the exposed surface up to the embedded steel bar corroding surface [1, 2, 8].
