Experimental in-plane behavior and retrofitting method of mud-brick walls

F. Tootoonchy, B. Asgarian*, F. Danesh

Abstract

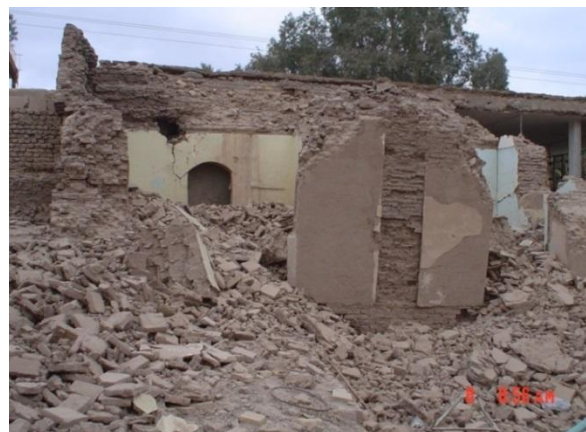
Fig. 1 A view of one sample destroyed adobe house after Bam earthquake

Adobe building made from mud-brick is a construction system that uses mud-brick to form bearing or non-bearing walls. It is estimated that about 30% of world's population lives in adobe and mud-brick buildings. In addition a number of historical and archeological building made from mud-brick. A lot of mud-brick buildings are in seismic active areas. As mud-brick is very brittle and low-strength material with heavy mass. Building made from this type of material are highly vulnerable in seismic active areas. A sample of destroyed adobe house after Bam earthquake is shown in Fig. 1.

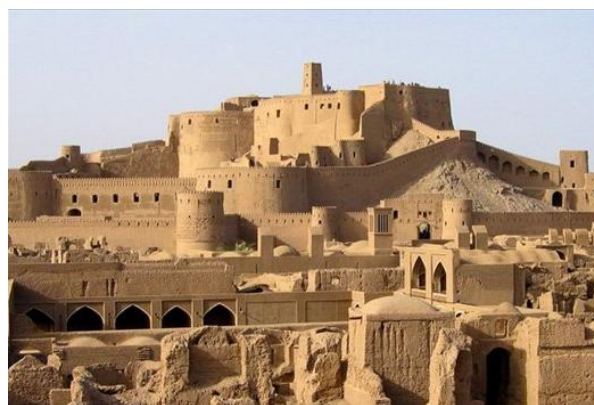
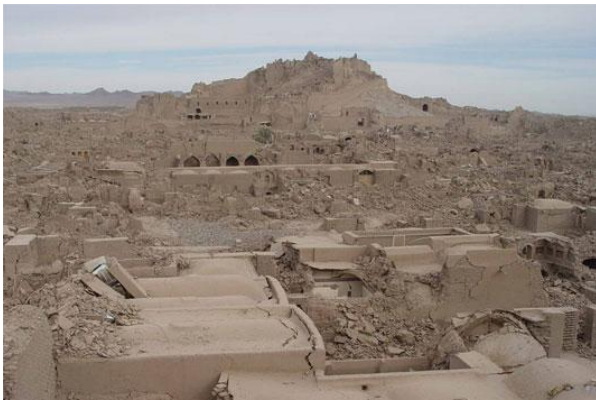
Fig. 2 View of Bam Citadel before and after Bam earthquake

The largest mud-brick structure is the Bam citadel which has been suffered serious damages during 2003 Bam earthquake. During Bam 2003 earthquake, most of the adobe buildings were destroyed, more than 26,000 people were died and over 60,000 were left without shelter [1]. Fig. 2 shows Bam citadel before and after 2003 earthquake.

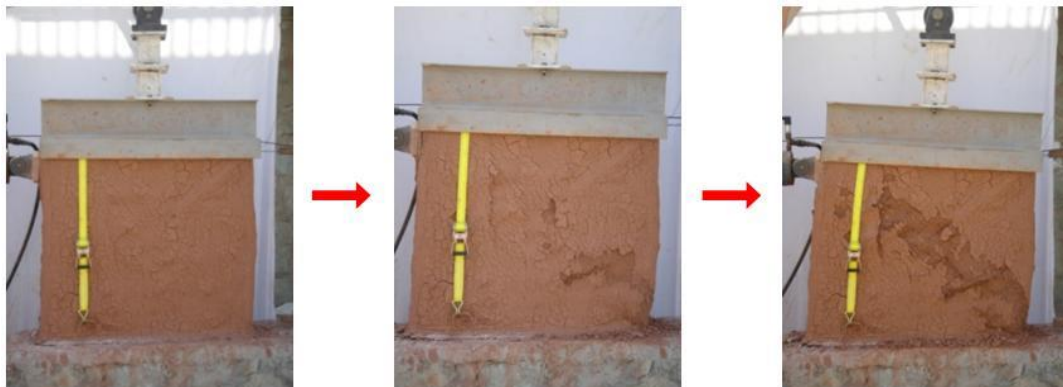
Fig. 18 Damage mechanism of RMW2 wall

Fig. 18 shows the damage mechanism of RMW2 wall. It was observed that with starting the load and upon completion of initial stages, volume of the wall toe was increased. Since, there was no possibility of occurrence of rocking motion mechanism, the wall begins forming diagonal cracks and ultimately the test is stopped by tearing of the net from the overlapping point in the wall toe.
