Technical Note

Repair effectiveness of CFRP and steel plates in RC beams with web opening: effect of plate thickness

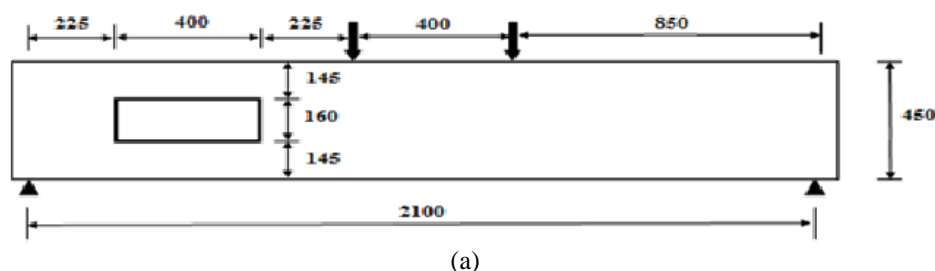
Fig. 2 Locations of strain gauge

The behaviour of load-strain relationship for externally bonded CFRP and steel plates is presented in this section. Strain gauge are fixed at two locations , one locations is on the opening corner near the support (ST2) and another location is at the opening corner near the point of applied load (ST1), as shown in Fig. 2(b). The load against strain curves for beams B1, B2, B3 and B4 are shown in Figs. 7, 8, 9 and 10, respectively. The recorded strains indicate that the value of strain for all beams did not reach the ultimate

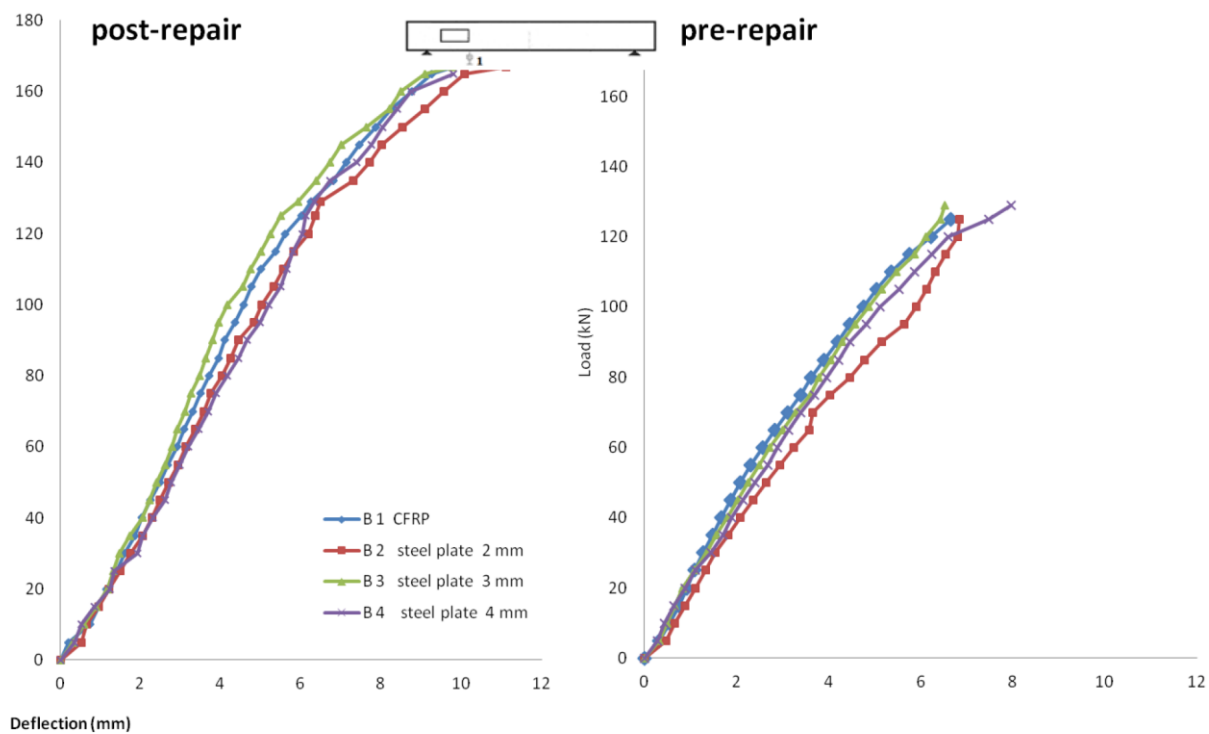
**Fig. 4** Load–deflection curves at the edge of the opening at pre and post repair stages

The load-deflection relationship at the mid span and below the edge of the opening is presented in this section. All the beams showed lower deflection at the mid span as compared to the deflection at the edge of the opening. For deflection at the edge of the opening, the reduction in deflection values found to be 10 % for CFRP, as shown in Table 4. For steel plates, the reductions in deflection were 7 %, 9 %, and 10 % for thicknesses of 2 mm, 3 mm and 4 mm, respectively. Thus, it is clear that the externally bonded plates applied around the web opening are capable of reducing 10 % of the deflection at pre-repair stage.

The beam B2, which was repaired by a steel plate with a thickness of 2mm, shows an effect on deflection at the edge of the opening, where at load of 128 kN the deflection is 6.98 mm and 6.49 mm at pre and post repair stages, respectively. For beam B3, good effect on the load capacity and a good effect on deflection were proved. The highest value of deflection was 6.52 mm obtained at the edge of the opening and it was at the pre-repaired stage at a failure load of 129 kN. However, at the post-repair stage, the deflection for the same load of 129 kN was 5.92 mm. As shown in Fig. 4, which shows the load against deflection at edge of opening curves at pre and post repair stages, the highest effect on deflection was for beams B1 and B4, while the lowest effect on deflection was for beam B2. The value of deflection for beam B1 at the pre-repair stage was 6.58 mm at a failure load of 125.2 kN, while the deflection was 5.95 mm at the post-repair stage at the same load of 125.2 kN.

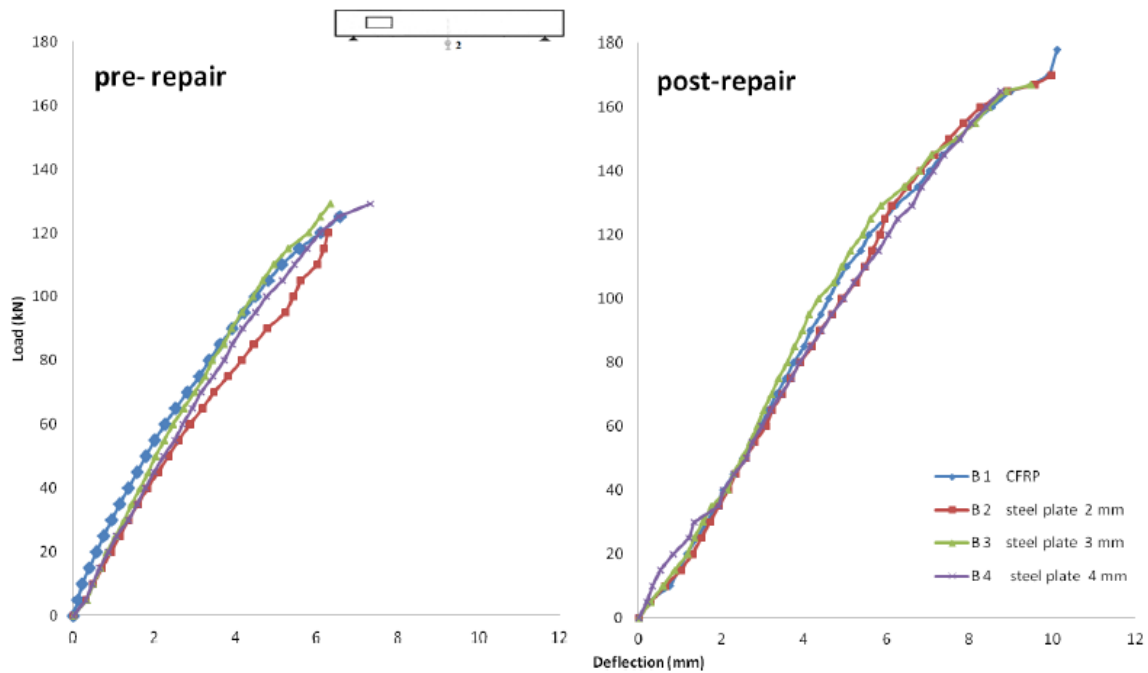
Fig 5. Load against deflection curves at the mid-span at pre and post repair stages

For beam B3, the value of deflection at the pre-repair stage at failure load of 129 kN was 6.35 mm, while at post-repair stage it was 5.85 mm at the same load of 128 kN. The value of deflection for beam B4 at the pre-repair stage was 6.74 mm at a failure load of 129.3 kN, while at the post-repair stage the deflection was 6.14 mm at the same load of 129.3 kN. The result shows that the influence of steel plates on deflection at the edge of the opening increases with the increase in steel plate thickness. The results indicate that the CFRP and steel plates have good effectiveness in reducing the deflection for the repaired beams at the edge of the opening and mid-span of the beam. From Fig. 5, which shows the load against deflection at mid-span curves at pre and post repair stages, it can be seen that curves for repaired beams show

somewhat similar behaviour because both CFRP and steel plates around the opening serve in resisting stress concentration at opening corners. Thus, it is delaying the cracking and controlling width and propagation of cracks. The highest value of deflection was obtained was located at the edge of the opening. The results are in agreement with Tan et al. [20], who found that for beams with an opening, the maximum deflection usually occurs at the high moment end of the opening. The decrease in deflection is smaller for the repaired beams, since the CFRP and steel plates prevent cracks from developing and widening. Furthermore, some contribution to the stiffness of beams was caused by the CFRP and steel plate outside the cracking region. The result shows that increasing steel plate thickness has little effect on reducing the deflection.

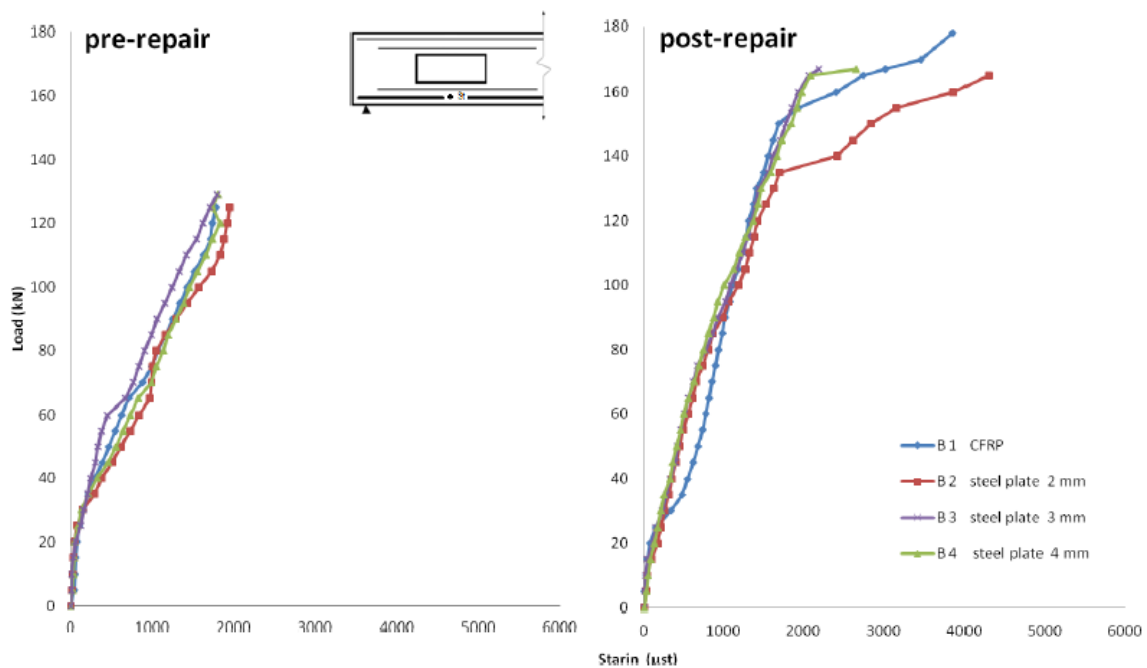
Fig. 6 Load against steel bar strain of (St) at pre and post repair stages

The load-strain relationship of steel reinforcement is presented in this section. The strain gauge (St) was attached onto the main steel reinforcement bar at the middle of the opening in the bottom chord. Fig. 6 shows the load against steel bar strain of the strain gauge (St) at the pre and post repair stages. For all the beams at the pre-repair stage, the strain gauge (St) shows an increase in strain value with the

increase in applied load and reaches its yielded strain at the ultimate load. At the post-repair stage, the externally bonded CFRP and steel plate shared the strain with steel bars where the strain gauge (St) reached strain values less than the strain at the pre-repair stage at same load. This was subjected to a different in the decrease of strain values percentage a depending on the material and thickness that were used, as shown in Table 5.

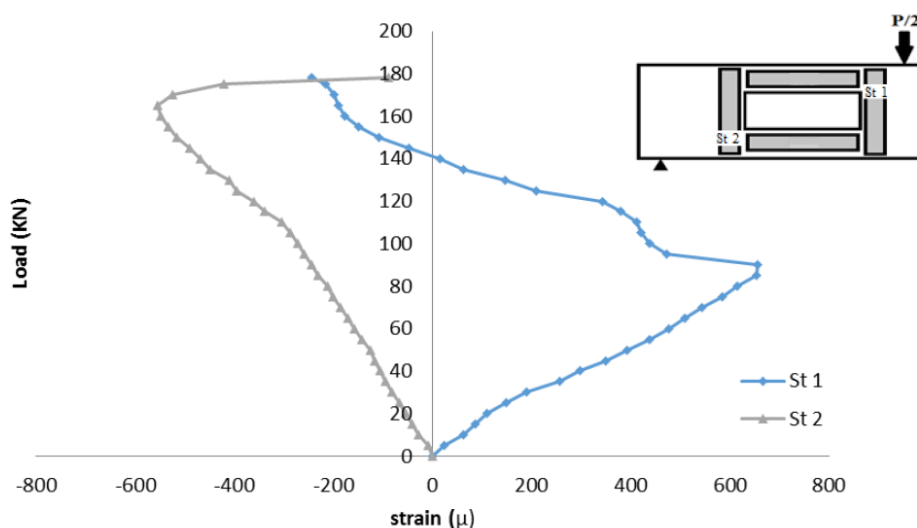
Fig. 7 Load against strain of externally bonded CFRP plates of beam B1

As can be seen from Fig. 7, for beam B1 the maximum CFRP strain measured at failure was in strain ST1. For beam B3, the steel plate strain measured at failure was deferent at each location, because the value of the strain greatly depends on the location of the strain gauge with respect to a crack, as shown in Fig. 9. It can be observed from Fig. 10 that for beam B4, the maximum CFRP strain measured at failure was in strain ST1, on the bottom chord of the opening. CFRP and steel plates were not fractured or debonded from the concrete surface, and this ultimately indicates that CFRP and steel plates could provide additional strength if the beams did not fail by concrete diagonal shear cracks.

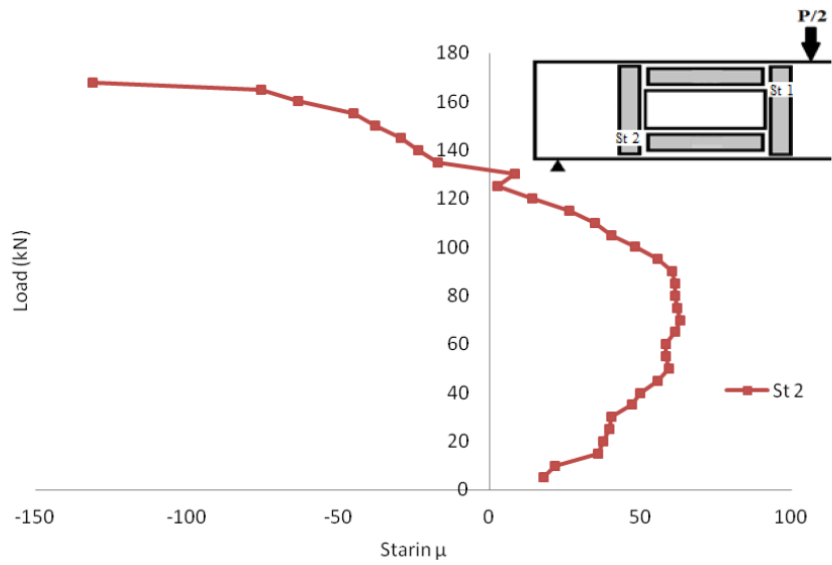
Fig. 8 Load against strain of externally bonded steel plate of beam B2

strain of CFRP and steel plates. This is due to the fact that the concrete failed before allowing the repair materials to reach the ultimate strain values. It can be observed from Figs. 7 to 10 that the externally bonded plates start to share the strain in the beam from the start of the applied load. The results are in agreement with Khalifa and Intomio [20], who found that the maximum CFRP vertical strain measured at failure corresponded to 14 % of the reported CFRP ultimate strain. This value is not absolute, because it greatly depends on the location of the strain gauge with respect to a crack.
