Technical Note

Repair effectiveness of CFRP and steel plates in RC beams with web opening: effect of plate thickness

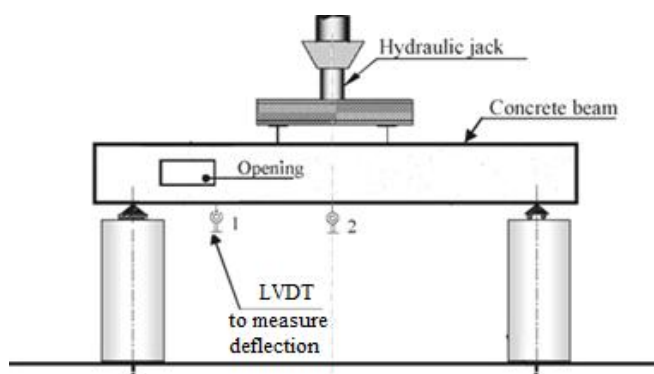
Fig. 1 Test set-up

All beams were tested as simple supported beams subjected to a four-point load, as illustrated in Fig. 1. A universal testing machine with 300 kN capacity was used in order to apply the load on a steel distribution I- beam, which was used to generate the two concentrated loads on the beam. The load was applied gradually with a speed of 4 kN/min and was then released with the same average. Two linear variable differential transformers (LVDT) were used in each test to monitor vertical deflection at two locations, edge of the opening and mid-span of the beam as shown in Fig. 1. For each beam, one strain gauge was attached to the main flexure steel bars below the opening, as shown in Fig. 2 (a). For all the beams, two strain gauges were attached directly to the CFRP and steel plate on the sides of beams to monitor strain variation in CFRP and steel plates, as shown in Fig. 2 (b). All the used electrical devices (load cell, LVDT, and strain gauges) are attached to the data logger in order to monitor the variation in load, deflection and strain values, corresponding to applied loads. The readings were carried out at each 5 kN load step and up to the ultimate applied load. All the beams were subjected to failure load at the pre-repair stages. The beams were then unloaded by bringing back the loading to zero.

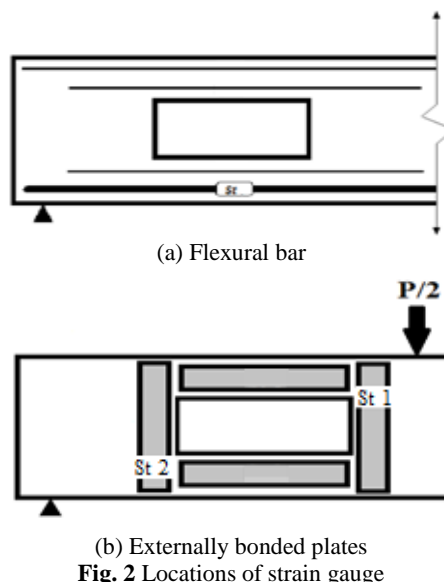
Fig. 2 Locations of strain gauge

(a)

(b) Externally bonded plates

The load-strain relationship of steel reinforcement is presented in this section. The strain gauge (St) was attached onto the main steel reinforcement bar at the middle of the opening in the bottom chord. Fig. 6 shows the load against steel bar strain of the strain gauge (St) at the pre and post repair stages. For all the beams at the pre-repair stage, the strain gauge (St) shows an increase in strain value with the

The behaviour of load-strain relationship for externally bonded CFRP and steel plates is presented in this section. Strain gauge are fixed at two locations , one locations is on the opening corner near the support (ST2) and another location is at the opening corner near the point of applied load (ST1), as shown in Fig. 2(b). The load against strain curves for beams B1, B2, B3 and B4 are shown in Figs. 7, 8, 9 and 10, respectively. The recorded strains indicate that the value of strain for all beams did not reach the ultimate
