Investigation of long term coupled effect of high temperature and constant high humidity on corrosion rehabilitated patches of reinforced concrete structures

Abstract

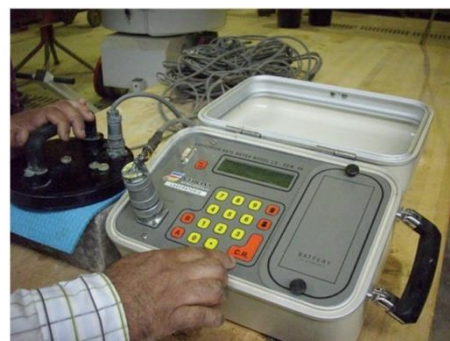
Figure 4 GECOR-8 (Corrosion Measurement device)

The steel rebar corrosion current (I_{corr}) and corrosion potential (E_{corr}) were measured for all specimens using a GECOR device [11] and ASTM C-876 [12]. The GECOR measures the corrosion rate as reflected by the corrosion current density and the half-cell corrosion potential. A true measure of the corrosion rate is possible by the polarization resistance technique. It has been well established by Stern and Geary that the corrosion current is linearly related to the polarization resistance, which gives a direct quantitative measurement of the amount of steel turning into oxide at the time of measurement. By Faraday's equation, this can be extrapolated to direct metal sectional loss. The corrosion current values in GECOR (GECOR-8, 2012) are calculated from the polarization resistance R_p using the relation $I_{corr} = B/R_p$, where I_{corr} is given in $\mu A/cm^2$ when R_p is given in $k\Omega/cm^2$ and $B = 26$ mV. The I_{corr} is directly proportional to corrosion rate through the relation, corrosion rate ($\mu m/year$) = $11.6 \times I_{corr}$. This gives a tool for quantifying the average reduction of rebar diameter over time. The measurement of corrosion rate usually involves applying electrical signal through a connection to the steel bar. In GECOR this signal is confined to the steel rebar in a circle with a diameter of 110 mm. There is evidence that this technique gives a more accurate measurement of the corrosion rate [13]. The GECOR device is quite valuable and versatile for the corrosion measurement of steel in concrete. See Fig. 4 for further illustration.

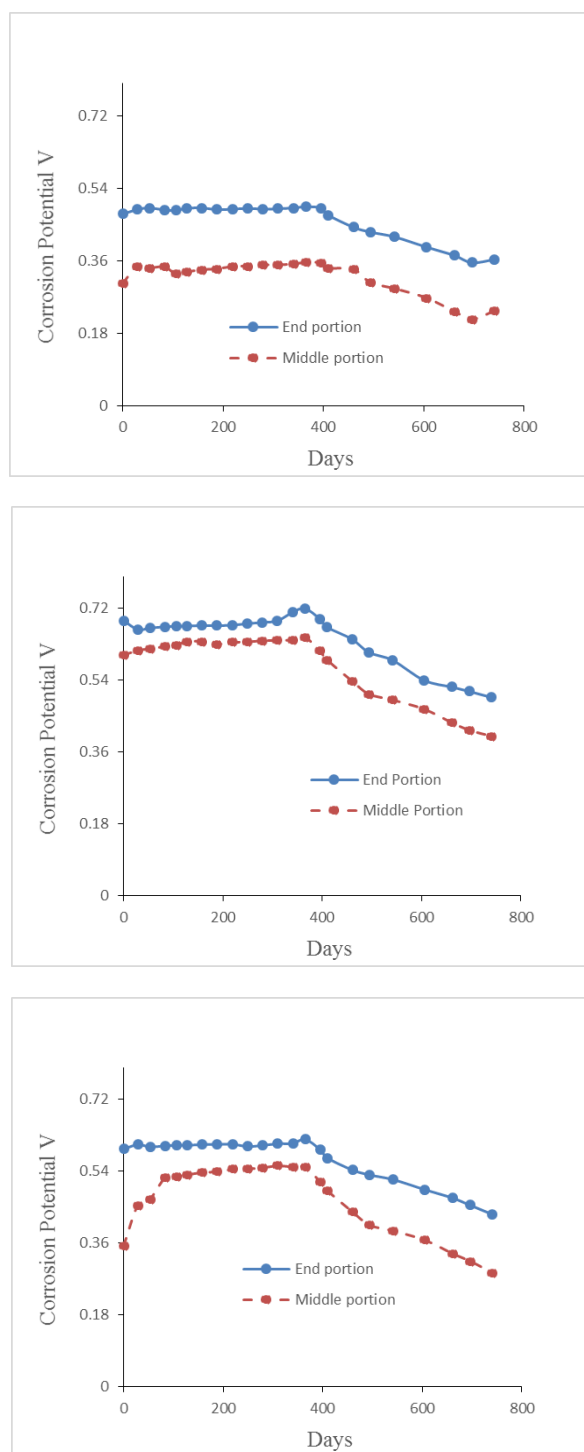
Fig. 5 (a-c) Corrosion potential measurement for 5% contaminated chloride specimen at the end kept at 30°C, 40°C and 50°C

1) At the middle non contaminated portion of the specimen having 5% chloride at the end portions and kept at 50°C (#1 and #2), the maximum corrosion of **-0.235** Volts was found after 2 years as compared to **-0.285** Volts at 30°C in the middle zero chloride portion of the same specimens (#5 and #6). However previously, much higher readings of these specimens were obtained on completion of one year observations [10]. The reason of this phenomenon could be the long term coupled effect of temperature and constant high humidity due to which the decline in corrosion potential after two years was significant. The results are shown in Figs. 5 and 6.

2) The maximum corrosion potential reading of the specimens #1 and #2 was found **-0.363** Volts as compared to high chloride induced potentials of **-0.432** Volts (figure 5) of the same specimens #5 and #6 at 30°C (figure 4)
