Repair of Earthquake-Damaged Square R/C Columns with Glass Fiber-Reinforced Polymer

Sassan Eshghi¹, Vahid Zanjanizadeh²

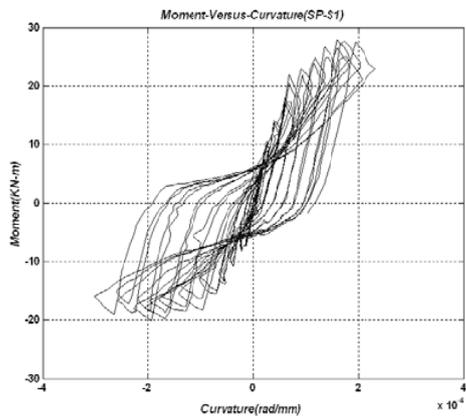
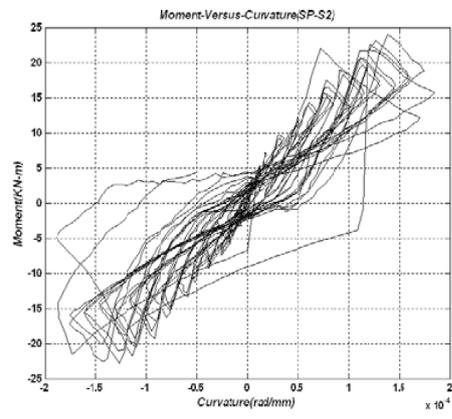
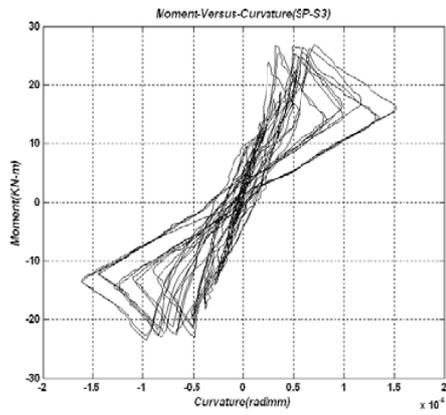
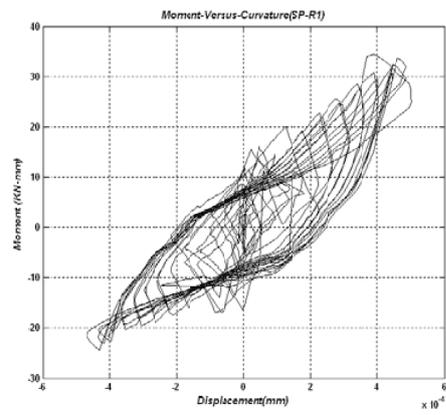
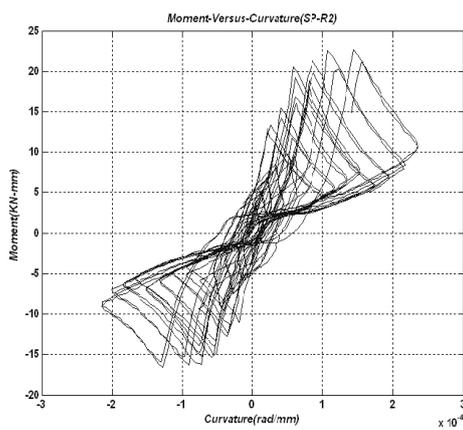
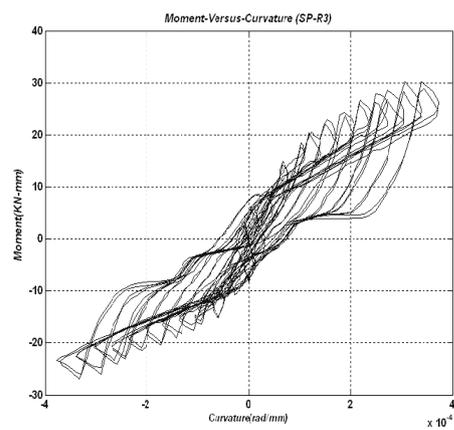
Fig.13 Moment –Curvature diagrams of the specimens

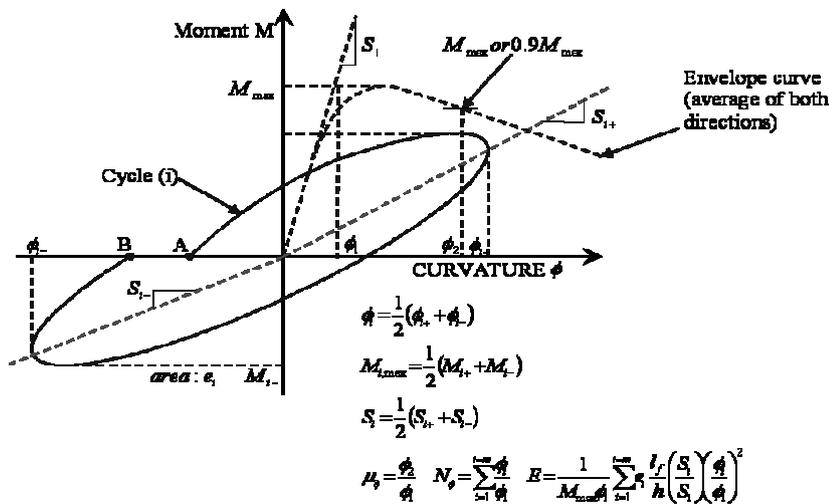
Fig.14 describes some ductility parameters including curvature ductility factor μ_ϕ , cumulative ductility ratio N_ϕ and energy damage indicator E . Subscripts t and 80 are added, respectively, to N_ϕ , E to indicate the value of each parameter at two different occasions: end of the test and end of the cycle in which the moment is dropped to approximately 80 percent of the maximum value. In Fig14, L_f represents the length of the most damaged region measured during the test and h represents the depth of the column section.

Fig.14 Definitions of section ductility parameters

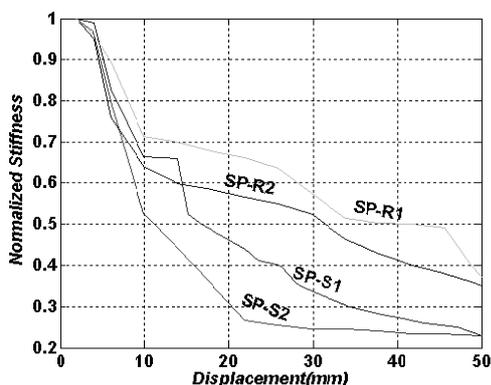
Stiffness for each cycle was calculated as the average of the stiffness for the positive and negative directions. Stiffness for each cycle was normalized with respect to the stiffness of the first cycle and was plotted versus the displacement. Stiffness degradation versus column top displacement after normalization is plotted in Fig.15 and Fig.16.

Fig.15 Normalized Stiffness versus Displacement for SP-S1, SP-S2, SP-R1 and SP-R2

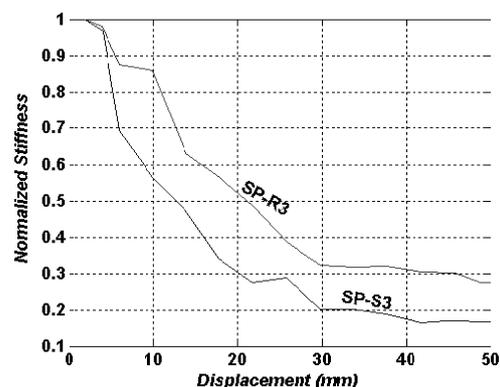
Fig.16 Normalized Stiffness versus Displacement for SP-S3, SP-R3
