# Repair of Earthquake-Damaged Square R/C Columns with Glass Fiber-Reinforced Polymer

Sassan Eshghi<sup>1</sup>, Vahid Zanjani-zadeh<sup>2</sup>

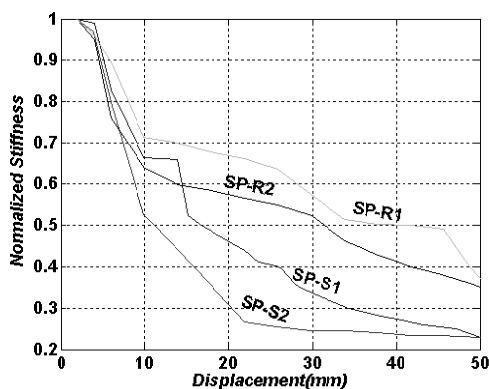
**Fig.15** Normalized Stiffness versus Displacement for SP-S1, SP-S2, SP-R1 and SP-R2

Stiffness for each cycle was calculated as the average of the stiffness for the positive and negative directions. Stiffness for each cycle was normalized with respect to the stiffness of the first cycle and was plotted versus the displacement. Stiffness degradation versus column top displacement after normalization is plotted in Fig.15 and Fig.16.
