Inspection and diagnosis system for rendered walls

Abstract

This paper presents an inspection and diagnosis system customized for rendered walls, both interior and external. It classifies all anomalies capable of affecting renderings and most of the likeliest corresponding causes and is supplemented by anomaly-cause and inter-anomaly correlation matrices. In addition, the diagnosis, repair and maintenance techniques suitable for these anomalies are classified. Examples of the files that contain the exhaustive characterization of the anomalies and diagnosis, repair and maintenance techniques are also presented.

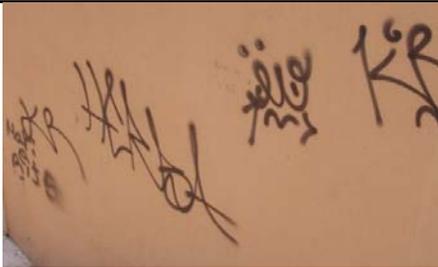
Table 9 Anomaly file A-E1 - *graffiti*

Anomaly file A-E1	
<p>Name: <i>Graffiti</i></p> <p>Description:</p> <p>Paintings or markings on the wall's surface that are absorbed due to the rendering's porosity</p> <p style="text-align: center;">Probable causes:</p> <ul style="list-style-type: none"> - Irregular cleaning/washing (C-U1) - Irregular repainting (C-U2) - <u>Vandalism (C-U6)</u> <p style="text-align: center;">Possible consequences:</p> <ul style="list-style-type: none"> - Aesthetics affected - Degradation of the visual quality of the rendering <p style="text-align: center;">Aspects to be inspected:</p> <ul style="list-style-type: none"> - Near schools or other locations with young crowds (Y/N) - Ease of access to the location (near the ground/elevated spot) - Type of graffiti (paint/spray/markers) - Percentage of area affected: (...) % <p style="text-align: center;">Recommended tests:</p> <ul style="list-style-type: none"> - <u>Visual inspection and macroscopic analysis (D-I1)</u> <p style="text-align: center;">Rating parameters:</p> <ul style="list-style-type: none"> - Aesthetic value of the areas affected (H-high/M-medium/L-low) - Conditions for repetition of the phenomenon (Y/N) - Percentage of area affected: (...) % <p style="text-align: center;">Level of gravity/intervention urgency:</p> <p>0 - building aesthetics seriously affected or high probability that the phenomenon will occur again and area affected over 20%;</p> <p>1 - all other cases</p>

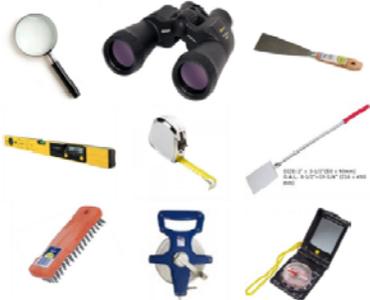
Table 10 Diagnosis technique file D-II - visual inspection and macroscopic analysis

Diagnosis file D-II	
<p>Name: Visual inspection and macroscopic analysis</p> <p>Destructive (d) / non-destructive (nd): ND</p> <p>Objectives: <u>Preliminary diagnosis:</u></p> <ul style="list-style-type: none"> - Initial identification of the anomalies on the rendering surface, of the most affected areas, the probable causes and the extent of the anomalies <p style="text-align: center;">Equipment needed:</p> <p>Magnifying glass, binoculars, spatula, brush, extensible rods with mirror, compass, levelling device, ruler, wire plummet, tape, clinometer and strain gauge</p>

Description of the method:

1 - Observation of the surfaces under analysis; **2** - Use of auxiliary devices such as magnifying glass or binoculars; **3** - Inspection of the surface by touch/palpation, brush, spatula; **4** - Use of compass, spirit level, ruler, tape, wire plummet, tape, clinometer and strain gauge to collect some quantitative data to reinforce visual observation; **5** - Use of extensible rods with mirror to inspect less accessible locations

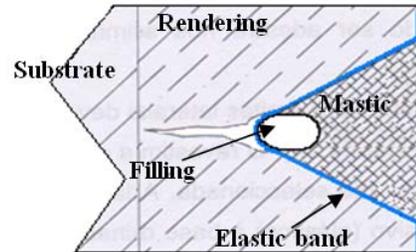
Table 11 Repair technique file R-B5 (creation of joints over live cracks)

Repair file R-B5	
Name:	Creation of joints over live cracks (rc) / (rp)
Element:	Rendering
Anomalies repaired:	A-H1 infiltrations/dampness stains; A-M1 loss of adherence/detachment; A-M2 loss of cohesion/crumbling; A-M3 linear cracking; A-M4 map cracking.
Materials used:	Elastic band, polyethylene or polyurethane foam roll (filling), polyurethane or special polymers mastic, coating material similar to the existing one.
Equipment needed:	Hammer, chisel, grinder, compressed air pistol, spatula, manual or pneumatic pistol and brush or roll.
Substrate preparation:	The intervention area must be clean, dry and free of loose particles and debris or contaminated elements that may jeopardize the adherence of the products to be applied.
Description of the technique:	All repair techniques must be implemented only after the elimination of the causes of the relevant anomalies. 1 - Widening of the cracks to be repaired, leading preferably to "V" sections 5-10 mm deep and 5-25 mm wide; 2 - Cleaning and elimination of all debris or contaminated elements that may jeopardize the adherence of the products to be applied; 3 - Application of an elastic band over the crack that must be fixed only at the limits of the crack; 4 - Application of a polyethylene or polyurethane foam roll, usually called a filling. This roll must be applied in order to stay compressed between the sides of the crack; 5 - Application of a polyurethane or special polymer mastic using a spatula or a manual or pneumatic gun; 6 - Application of the coating, which must be elastic and preferably reinforced with a grid, and executed keeping the desired aesthetic finishing in mind.

Workmanship and estimated execution time:	1 mason + 1 helper (0.12 to 0.14 m/h).
Estimated cost¹:	12 to 16 €/m ² according to the maker and depth of the materials. (1) This figure must be increased by the cost of scaffolding, whenever needed.
Recommendations and special care:	Fix the elastic band only at the ends of the crack. Apply to non-stabilized cracks with a regular outline and no abrupt changes in width.
Limitations:	Relatively complex execution procedure, open to mistakes. The creation of a joint where there was none is mandatory, and this may have aesthetic consequences.

Table 11 shows an example of a repair file for technique R-B5 (creation of joints over live cracks).
