# Dry Sliding Friction and Wear Resistance of SnPb-Solder Affected Copper against Stainless Steel Counter Surface

**Abstract:** This paper reports the wear behavior of Cu, high Cu-Sn alloy, high Cu-Pb alloy and high Cu-Sn-Pb alloy under dry sliding at ambient conditions. These four materials were chosen for the wear resistance characterization of SnPb-solder affected old/scraped copper (high Cu-Sn-Pb alloy) to explore its reusing potentials. Wear tests were conducted using a pin-on-disk tribometer with the applied load of 20 N for the sliding distance up to 2772 m at the sliding speed of 0.513 ms<sup>-1</sup>. The applied load was also changed to observe its effect. The investigation reveals that the presence of a small amount of Sn increased the hardness and improved the wear resistance of Cu, while a similar amount of Pb in Cu reduced the hardness but improved the wear resistance. The general perception of 'the harder the wear resistant' was found to match partially with the results of Cu, Cu-Sn alloy and Cu-Sn-Pb alloy. Coefficient of friction (COF) values revealed non-linear gradual increasing trends at the initial stage and after a certain sliding distance COF values of all f

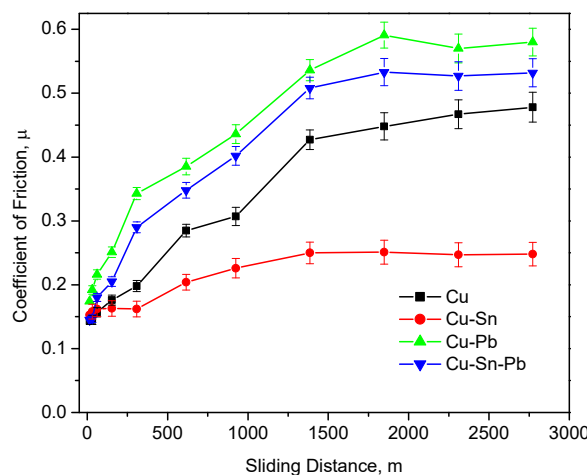
Coefficient of friction (COF) values have been obtained directly from the pin-on-disk apparatus and also calculated using Eq. (2). The results obtained for all four sample materials have been plotted against sliding distance in Fig. 5. COF values for all four sample materials at the initial sliding period are found to be significantly less under dry sliding condition. For instance, COF is only about 0.14 for the sliding period of 2 minutes covering the sliding distance of 15.4 m for all samples. Basically, COF depends on plowing mechanism, height of agglomerated particles,

number of particles and the tribological condition of the sliding system which includes lubrication level and normal load [28]. At the beginning of sliding, plastic deformation is significant when adhesion is weak, and thus, COF values for all samples are low. Once the sliding time or distance is increased, adhesion actions of the plastically deformed materials are increased and the COF values are rising gradually but non-linearly. The graphs in Fig. 5 have shown a non-linear gradual increasing trend of COF up to a sliding distance of about 1500 m and finally reached to some steady-state level for all four sample materials. With the increase of sliding distance, there is a transition from grooving abrasion to rolling abrasion, which has resulted in steady values of COF. However, Cu-Pb alloy has shown the highest COF amongst four sample materials over the entire range of sliding distance in the experiment with the maximum value of 0.591, which is followed by Cu-Sn-Pb alloy (max value 0.533) and then pure Cu (max value 0.478). The lowest COF has been observed for Cu-Sn alloy throughout the sliding distance with the maximum value of only 0.251 under dry sliding condition.

**Fig. 5.** COF against sliding distance at sliding speed of  $0.513 \text{ ms}^{-1}$  with normal load of 20 N (with the pressure of 1.02 MPa) in dry sliding condition.

From the present results, the hardest material (Cu-Sn alloy with micro-hardness value of 68.42 HV) shows the lowest values of COF and the softest material (Cu-Pb alloy with micro-hardness value of 51.05 HV) displays the highest COF values. It may be considered that the lower value of COF occurs for the higher hardness. But, Cu-Sn-Pb alloy being harder (66.87 HV) than pure Cu

(60.71 HV) is displaying higher COF than that of Cu unexpectedly, and thus, they are showing reverse behavior in this regard. Therefore, there is no strong relation to having lesser COF for harder materials, especially for alloys. Again lesser COF of Cu-Sn alloy than Cu and higher COF of Cu-Pb than Cu indicates that the alloying element may have sometimes a discriminating effect (rising or again falling) in friction, which also agrees with the findings of Buckley [29].

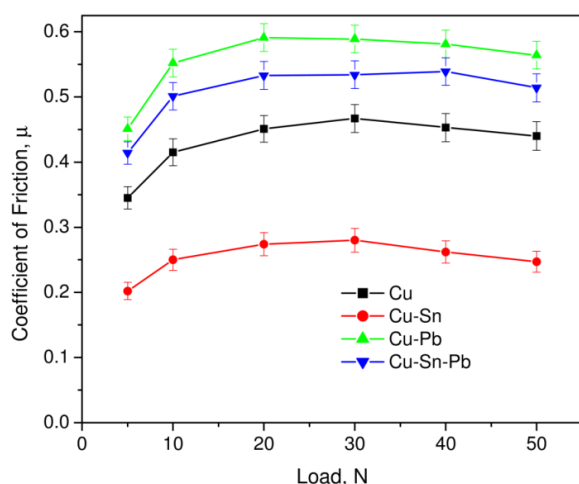
The effects of applied load on COF values of sample materials have been observed with the applied load of 5 N, 10 N, 20 N, 30 N, 40 N and 50 N for the sliding distance of 2772 m and the results are presented in Fig. 6. COF values of all four samples are almost of a similar pattern against load. It is seen in Fig. 6 that COF values are not maintaining constant characteristics as normally considered.

**Fig. 6.** COF against applied load at the sliding speed of  $0.513 \text{ ms}^{-1}$  for sliding distance of 2772 m.

All curves are showing increasing trends at the initial rise of loads, and thereafter, they have become steady with little reductions in COF values for the loads of 40 N and 50 N. The standard deviations of COF for pure Cu, Cu-Sn alloy, Cu-Pb alloy and Cu-Sn-Pb alloy for changing load from 5 N to 50 N are 0.044, 0.028, 0.053 and 0.047, respectively. COF is usually considered to be a constant value for a particular tribological environment irrespective of normal loading conditions. But, the present study has revealed that COF values can vary with the rise of normal loads for all four copper based materials, which also agrees with the behavior of Molybdenum Disulfide as seen by Karpe 1965

[30]. It confirms that the COF values are influenced by the normal load; however, the influence level for comparatively higher load is negligible.

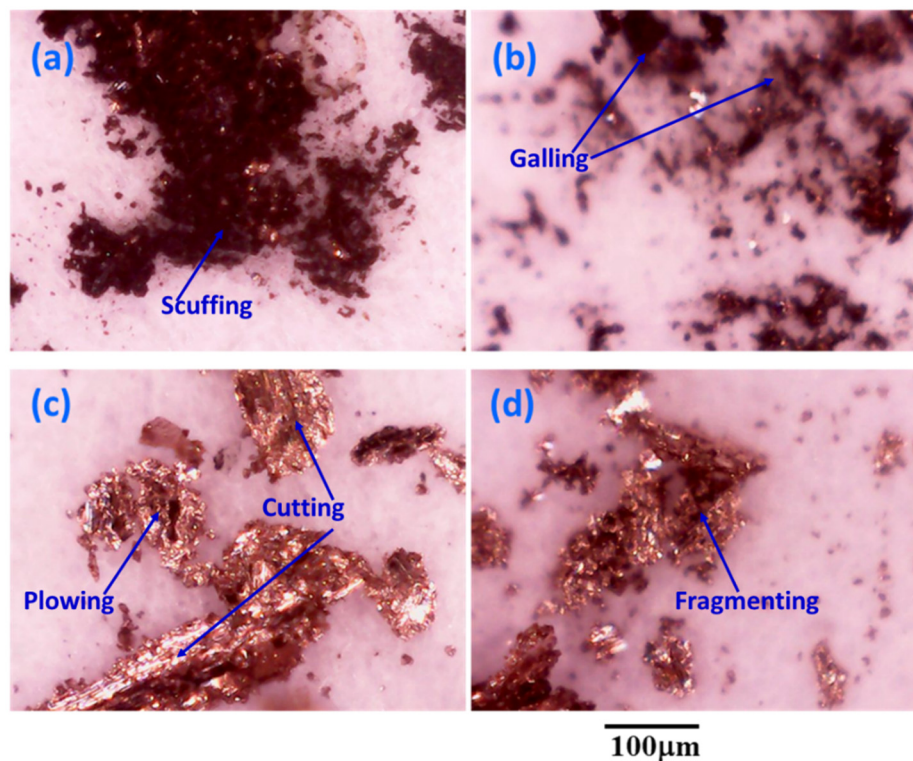
The micrographs of debris produced from pure Cu, high Cu-Sn alloy, high Cu-Pb alloy and SnPb-solder affected Cu after dry sliding are shown in Fig. 8. As seen in Fig. 8 (a), debris of Cu is of fine grains with small size distribution but not homogeneous. Figure 9 (b) indicates that Cu-Sn debris is small but irregular in size and shape. Figures 9(c) and 9(d) show comparatively larger flake like debris of high Cu-Pb alloy and SnPb-solder affected Cu. However, some fine particles are also evident amongst the coarse debris which might be indicating the slip and twinning effects during dry sliding. As a whole, no firm relation has been observed between the size of debris and the wear rate or COF of the four sample materials. FE-SEM images of the worn-out surfaces of pure

**Fig. 8.** Optical micrograph of the debris of experimental alloys generated during wear experiment with applied pressure of 1.02 MPa (Load = 20 N) and sliding speed of  $0.513 \text{ ms}^{-1}$  at dry sliding condition: (a) Cu, (b) Cu-Sn alloy, (c) Cu-Pb alloy and (d) Cu-Sn-Pb alloy.
